# Supplementary Guidance to the City of Leicester Local Plan 2006

## Church Gate Conservation Area Character Appraisal

Urban Design Group  
Adopted March 2006

## Character Appraisal

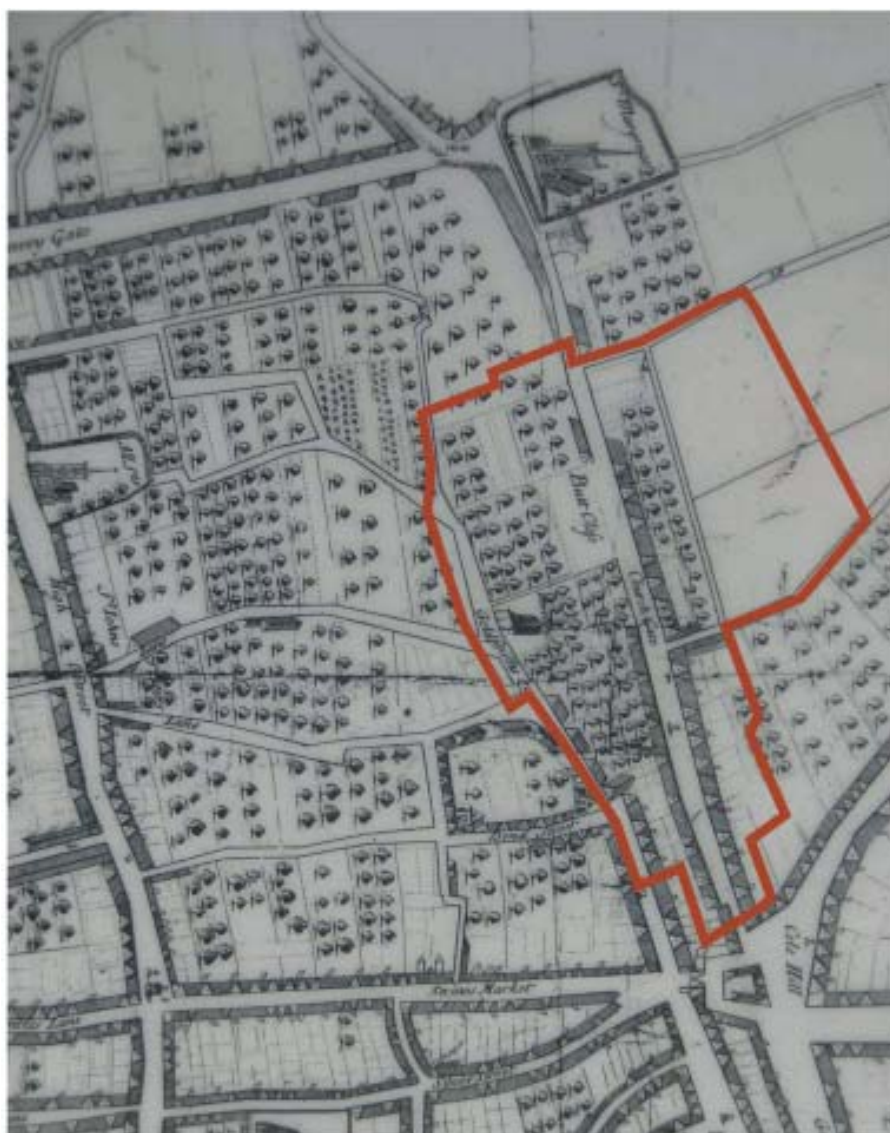
**Map 3.** Robert's map of 1741: The approximate area of Church Gate Conservation Area is shown superimposed.

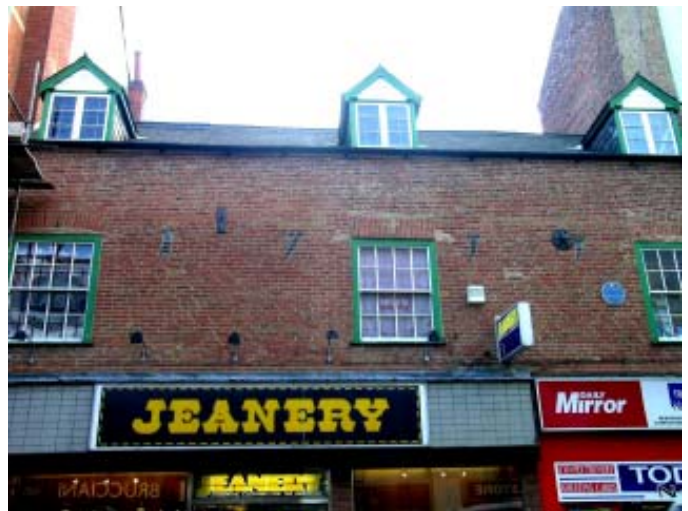
*Eighteenth century brickwork at 11-13 Church Gate.*

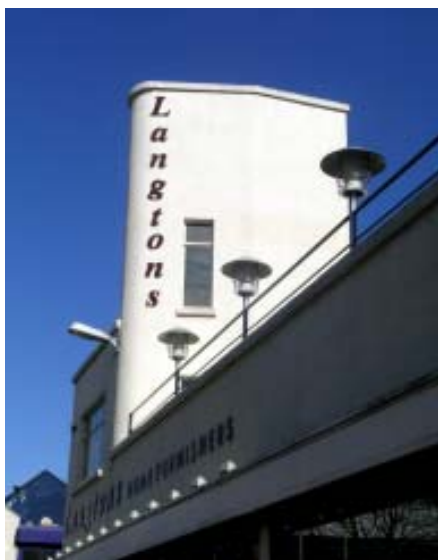
No 81 Church Gate was constructed in the Art Deco style. The tower forms a strong focal point at the corner of Gravel Street and Church Gate

was extended. It is in Art deco style – popular for such uses at that time - and features a tower that acts as a prominent local landmark.

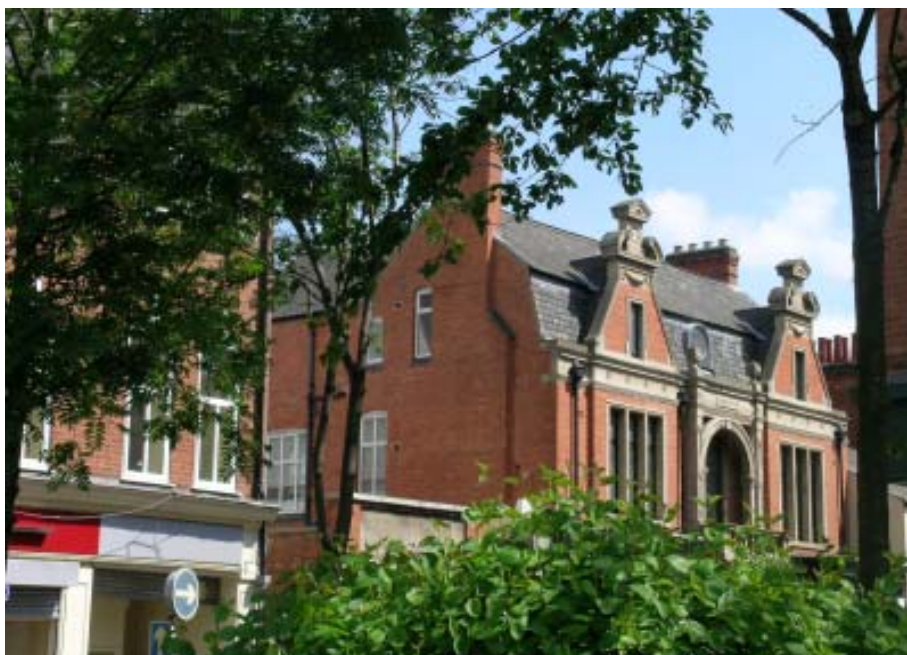
At 73 Church Gate the combination of red brick with elaborate stone detailing to windows and twin gables helps to create a strong architectural statement.

**4.27 73 Church Gate** is, in comparison, probably the most architecturally distinctive building on Church Gate. It is built in red brick with stone detailing, twin pedimented gables, a large recessed central window and a stone balustrade. It was built in the late 1890s as a house (Hasledene) and offices for a local builder, on a site identified as part of Goodwin & Barsby's iron foundry on the 1886 Ordnance Survey. It was subsequently used as an adult school, offices, a nightclub and has now been converted into shops. Next to it, **No.75 Church Gate** is an attractively proportioned, three storey Victorian warehouse that has been recently converted into a restaurant and flats but with unsympathetic upvc windows on the upper floors. Finally on the east side of Church Gate, the premises occupied by Langton's (**81 Church Gate**) at the corner of Gravel Street are of interest. They were built as a garage (Castle's Motors) in the 1930s, probably at the time when Gravel Street

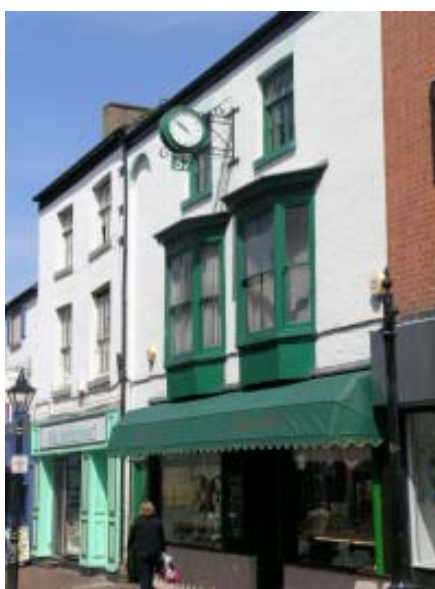
Traditional features such as these original sliding sash windows and a fine projecting jewellers clock at 37 Church Gate add greatly to the unique character of the area.

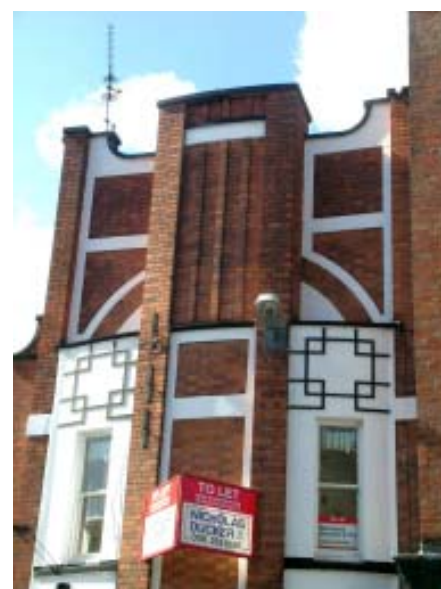
Brick and stucco at 66 Church Gate.

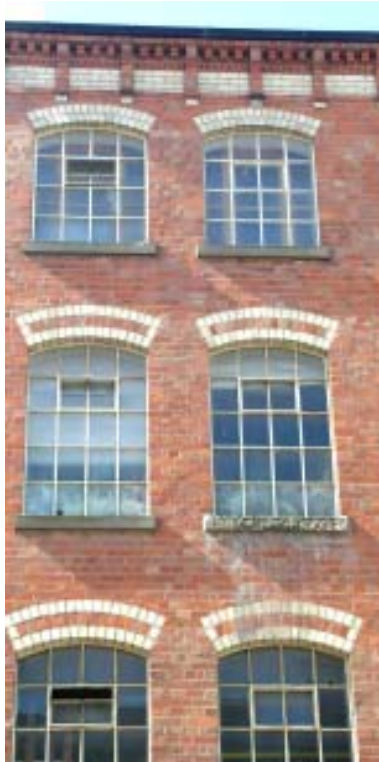
*Most of the architectural detailing including polychrome brickwork and original cast iron windows still survive to the upper floors of factory premises at 74-76 Church Gate.*

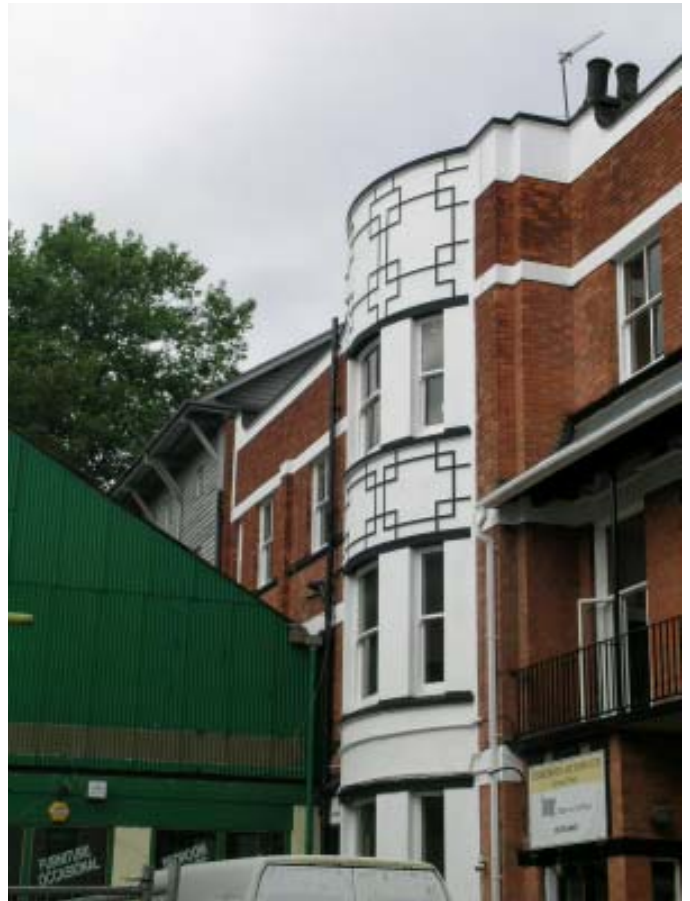
*The Art Nouveau detailing to the front and side elevations of 66 Church Gate with decorative balconies is, unusually for a commercial building, quite domestic in scale.*

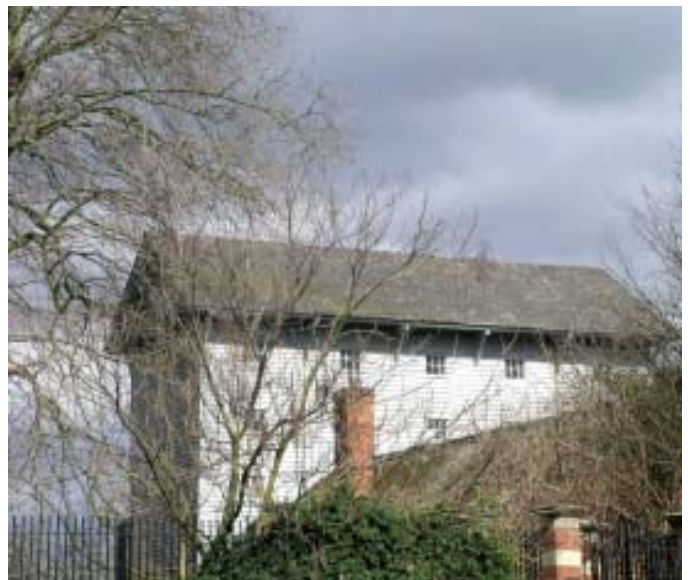
*To the rear of 66 Church Gate the unique Timber Warehouse is a listed Grade II building.*

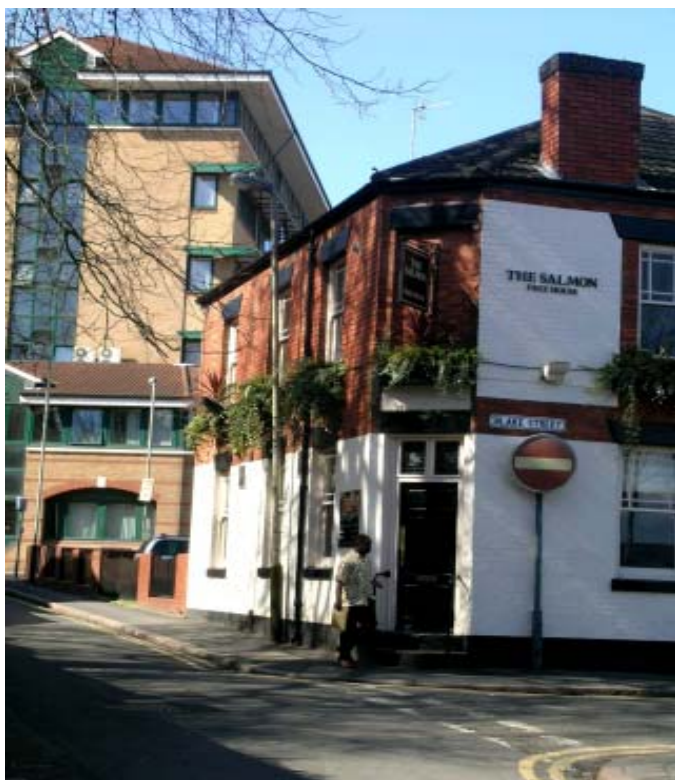
*The Salmon PH situated on the corner of Butt Close Lane and Blake Street.*

**4.30** At the corner of Butt Close Lane and Blake Street, **The Salmon** is a good, surviving example of a Victorian street corner public house. To the rear, **No.3 Darker Street** is a rare example of a hosier

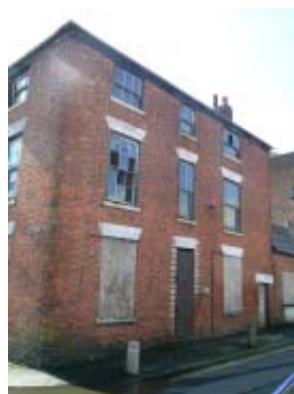
*No. 3 Darker Street is a rare survivor of a hosiery master's house and workshop.*

**4.64** Two buildings create cause for concern, however. The former hosiery master's house and workshop at 3 *Darker Street* is in poor condition, and was subject to an Urgent Works Notice in 2005 to secure the structure and prevent access. It remains vacant. The factory on the east side of *Short Street* is also vacant and the rear half of the building is subject to regular checks on its structural stability. At present it remains stable but not useable.

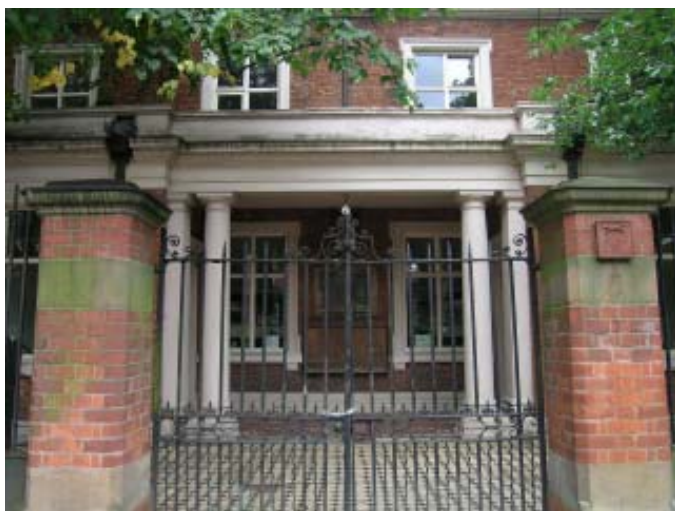
*The Great Meeting Chapel: dating from 1708 is Leicester's earliest surviving brick built building.*

**Chapel** is one of the earliest brick buildings (1707) of any importance in the city, built in a plain but solid manner with stucco detailing and a steeply-pitched slate roof. It became a Unitarian chapel in the 19<sup>th</sup> century and the front projection probably dates from that period. Alongside, the former schoolrooms date from 1859 and are built in red and yellow brick in Gothic Revival style, with pointed arch windows; it has been linked to the chapel with an attractive extension, clearly modern but echoing the style of the buildings. The adjacent **Cherry Tree** public house is an attractive three-storey former hotel that can be identified on the

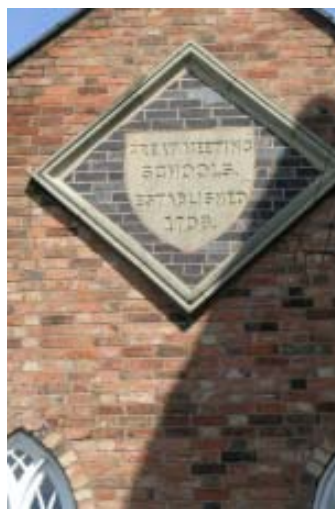
*This brick and stone commemorative plaque is sited on the west facing gable wall of the Great Meeting Chapel Schoolrooms.*

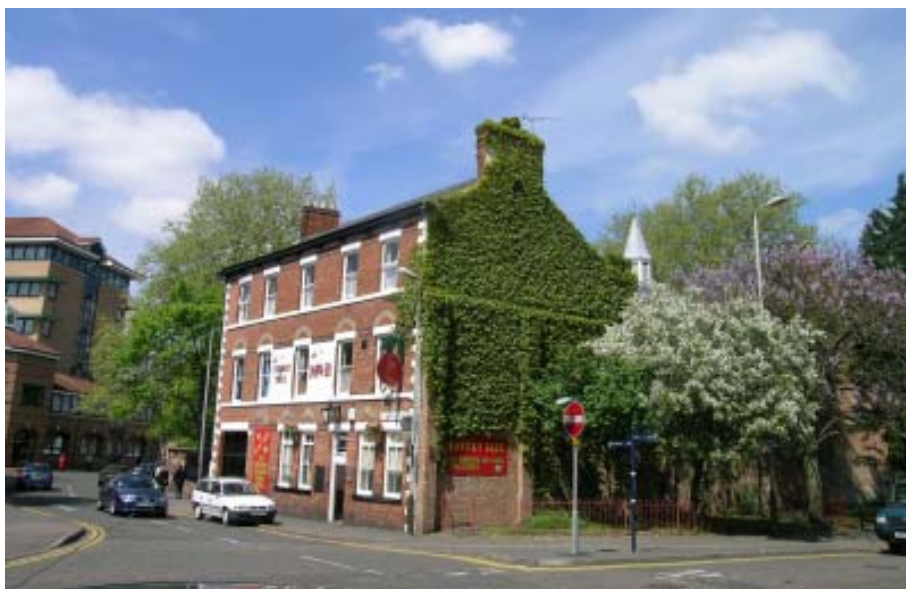
*The Cherry Tree Public House at the corner of St. Peter's Lane and East Bond Street is one of several traditional public houses within the conservation area.*

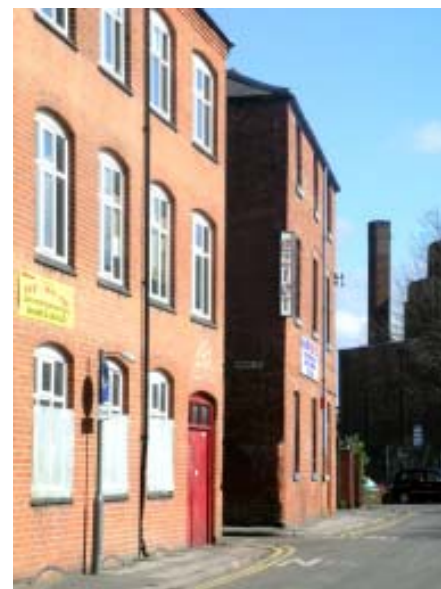
*Late 19th century factory buildings along Mansfield Street.*

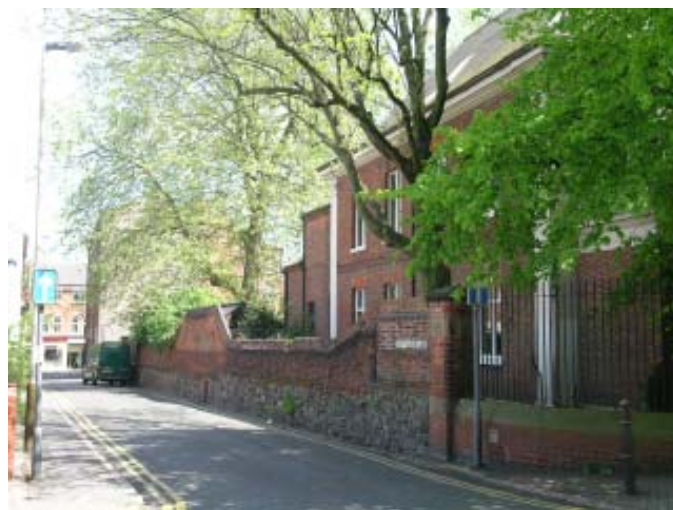
*Butt Close Lane: the 18th century boundary brick wall is constructed on the remains of an earlier stone rubble wall.*

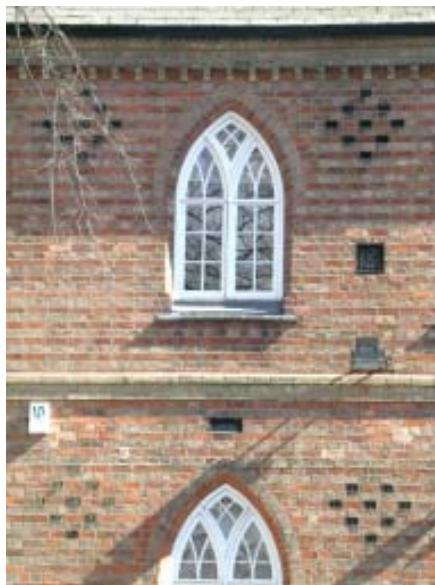
*The Great Meeting Chapel Schoolrooms is in a style known as 'Gothic Revival' and has delightfully patterned lozenge brickwork.*

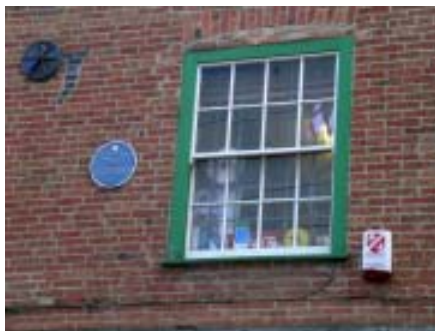
*Early brickwork at 11-13 Church Gate. The blue plaque commemorates Thomas Cooper of the Chartist Movement.*

**4.36** The development of the railway network from the 1840s onwards allowed bricks and other building materials to be imported from further afield. As a result, there is a noticeable distinction between the local orange-red bricks of the early buildings and the regular sized, machine-made darker red bricks used in the later Victorian buildings. This contrast in colour and size of the bricks is apparent when comparing Nos. 11-13 Church Gate and the early 20<sup>th</sup> century building alongside (Nos. 15-21).

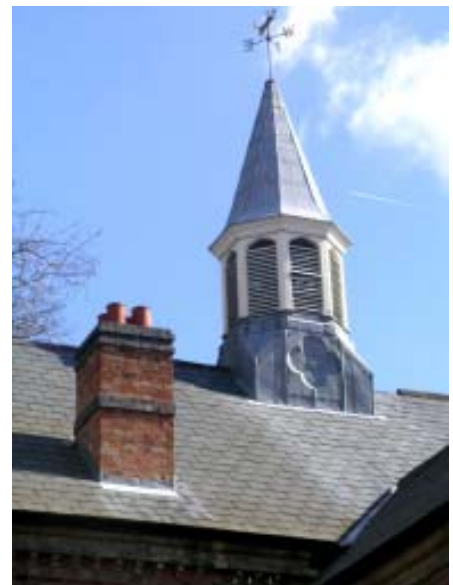
*The timber and lead covered cupola to the roof of the Great Meeting Schoolrooms supports a fine weathervane.*

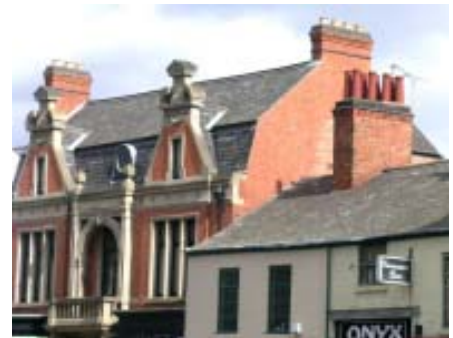
*Roof lines are important: at 73 Church Gate a Mansard type roof clad in Welsh slate adds much distinction.*

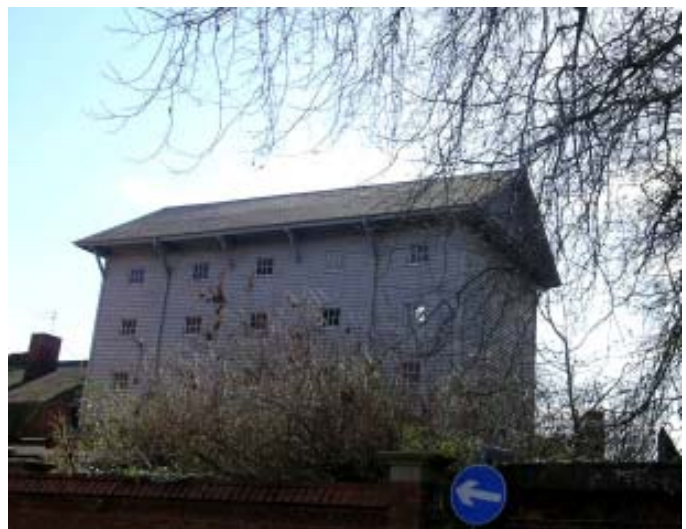
*Next to the former graveyard of the Great Meeting Church stands this timber warehouse built c1830. It was saved by the City Council in the mid 1970s.*

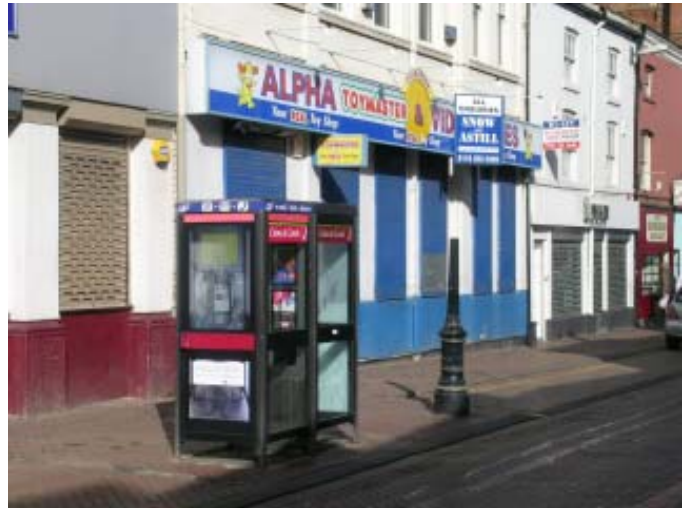
*Poorly designed shop signs and heavy security shutters together with badly maintained street furniture contribute to a loss of character in the conservation area.*

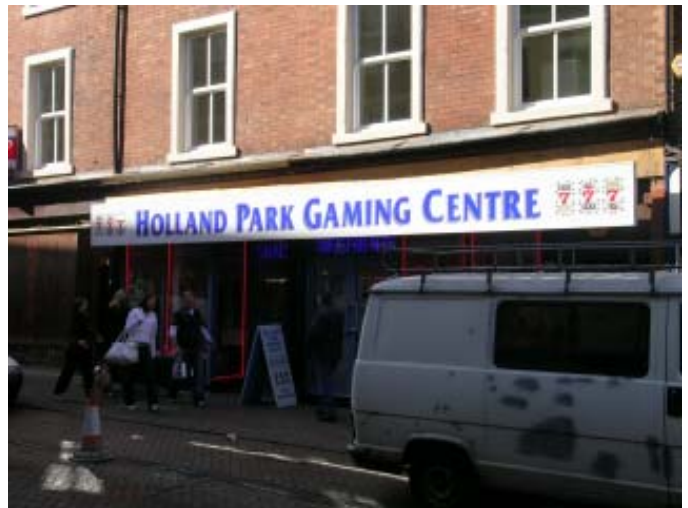
*The position of this internally illuminated box sign is particularly unfortunate. Shop signs should be designed to be respectful of the style and period of the shopfront and property.*

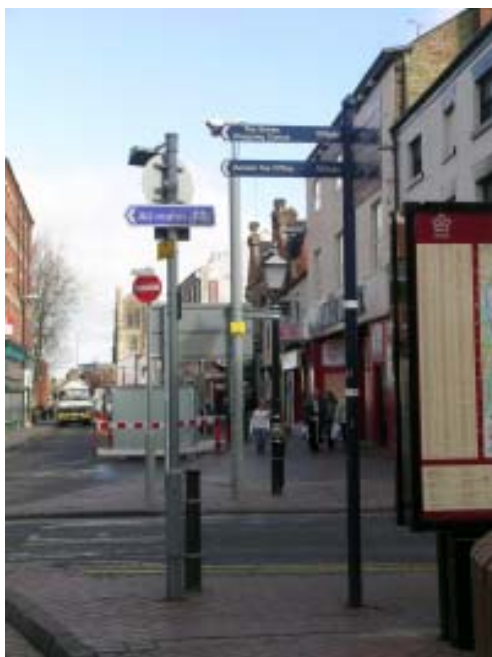
The collection of traffic direction and information signs at the junction of Mansfield Street and Church Gate are particularly intrusive.

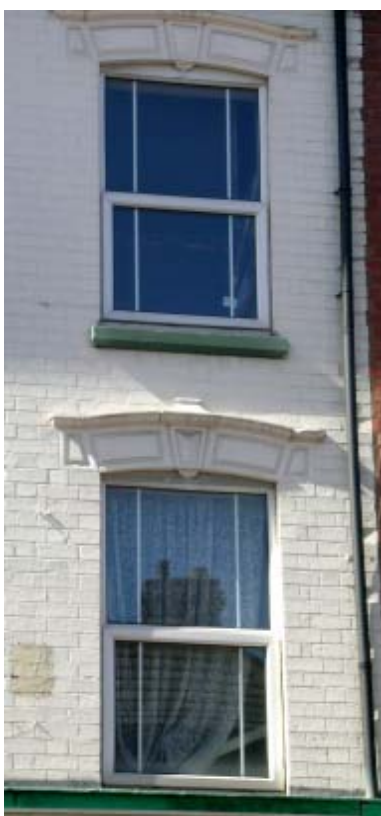
Windows are like the eyes on a human face - they are a point of contact that draw our attention and are an integral part of the architecture of a building. Their alteration or removal can reduce the value of a property both visually, historically and financially. These two examples from within the conservation area show windows that have been replaced with unsympathetic uPVC material.

**4.54** A number of original timber windows - especially on upper floors - have been replaced with upvc units, particularly over the past 10 years. Not only is upvc an alien material on 18<sup>th</sup> and 19<sup>th</sup> century buildings it cannot replicate the proportions, intricacy or fine detailing of the original timber windows. Upvc windows have also tended to be installed at the forward edges of window openings rather than being fully recessed. This results in a loss of texture, rhythm and subtle shadows and 'flattens' the façade. The windows installed at Nos. 41-43 Church Gate are an example where the character of an 18<sup>th</sup> century building has been compromised. Many new windows, even those made of timber, have outward opening 'mock' sashes, and these disrupt the visual rhythm of a terrace.

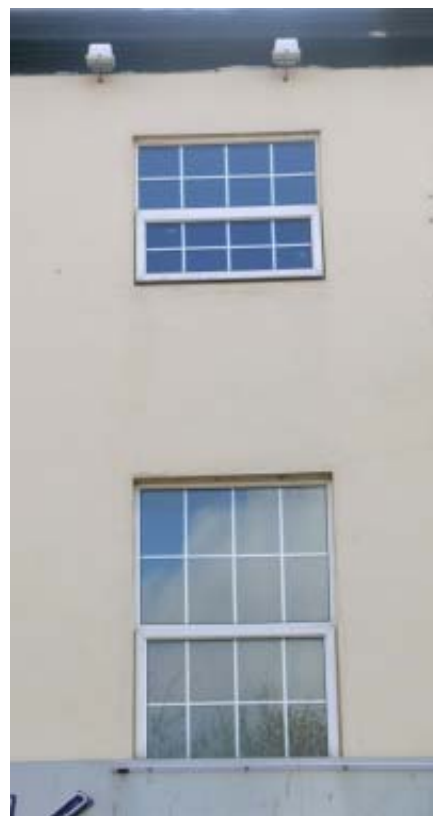
many locations solid security shutters have also been added and this has not only adversely affected the appearance of the buildings but has also created a depressing image when they are closed.

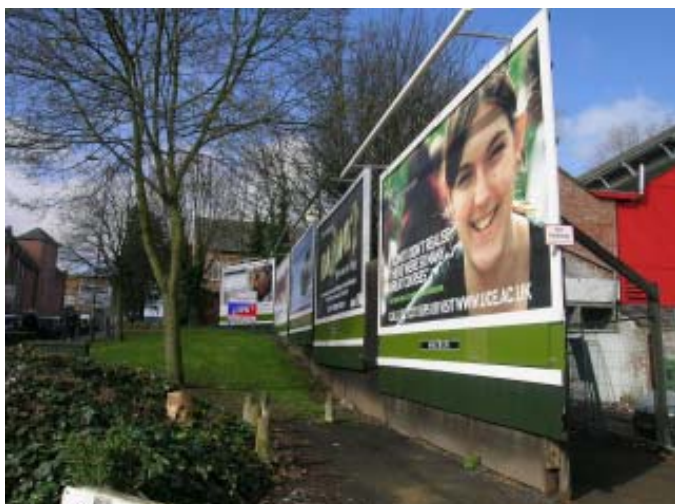
*Advertising hoardings on the north side of St Peter's Lane.*

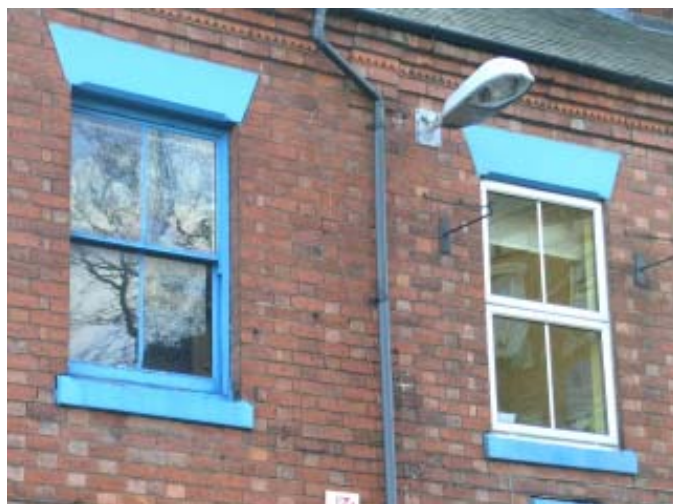
*Two different types of window from the same property: the window to the right has been replaced in uPVC. The window to the left is an original timber sliding sash and is complete with Victorian glass incorporating elegant vertical glazing bars.*
