St Paul's Conservation Area Character Appraisal

June 2022

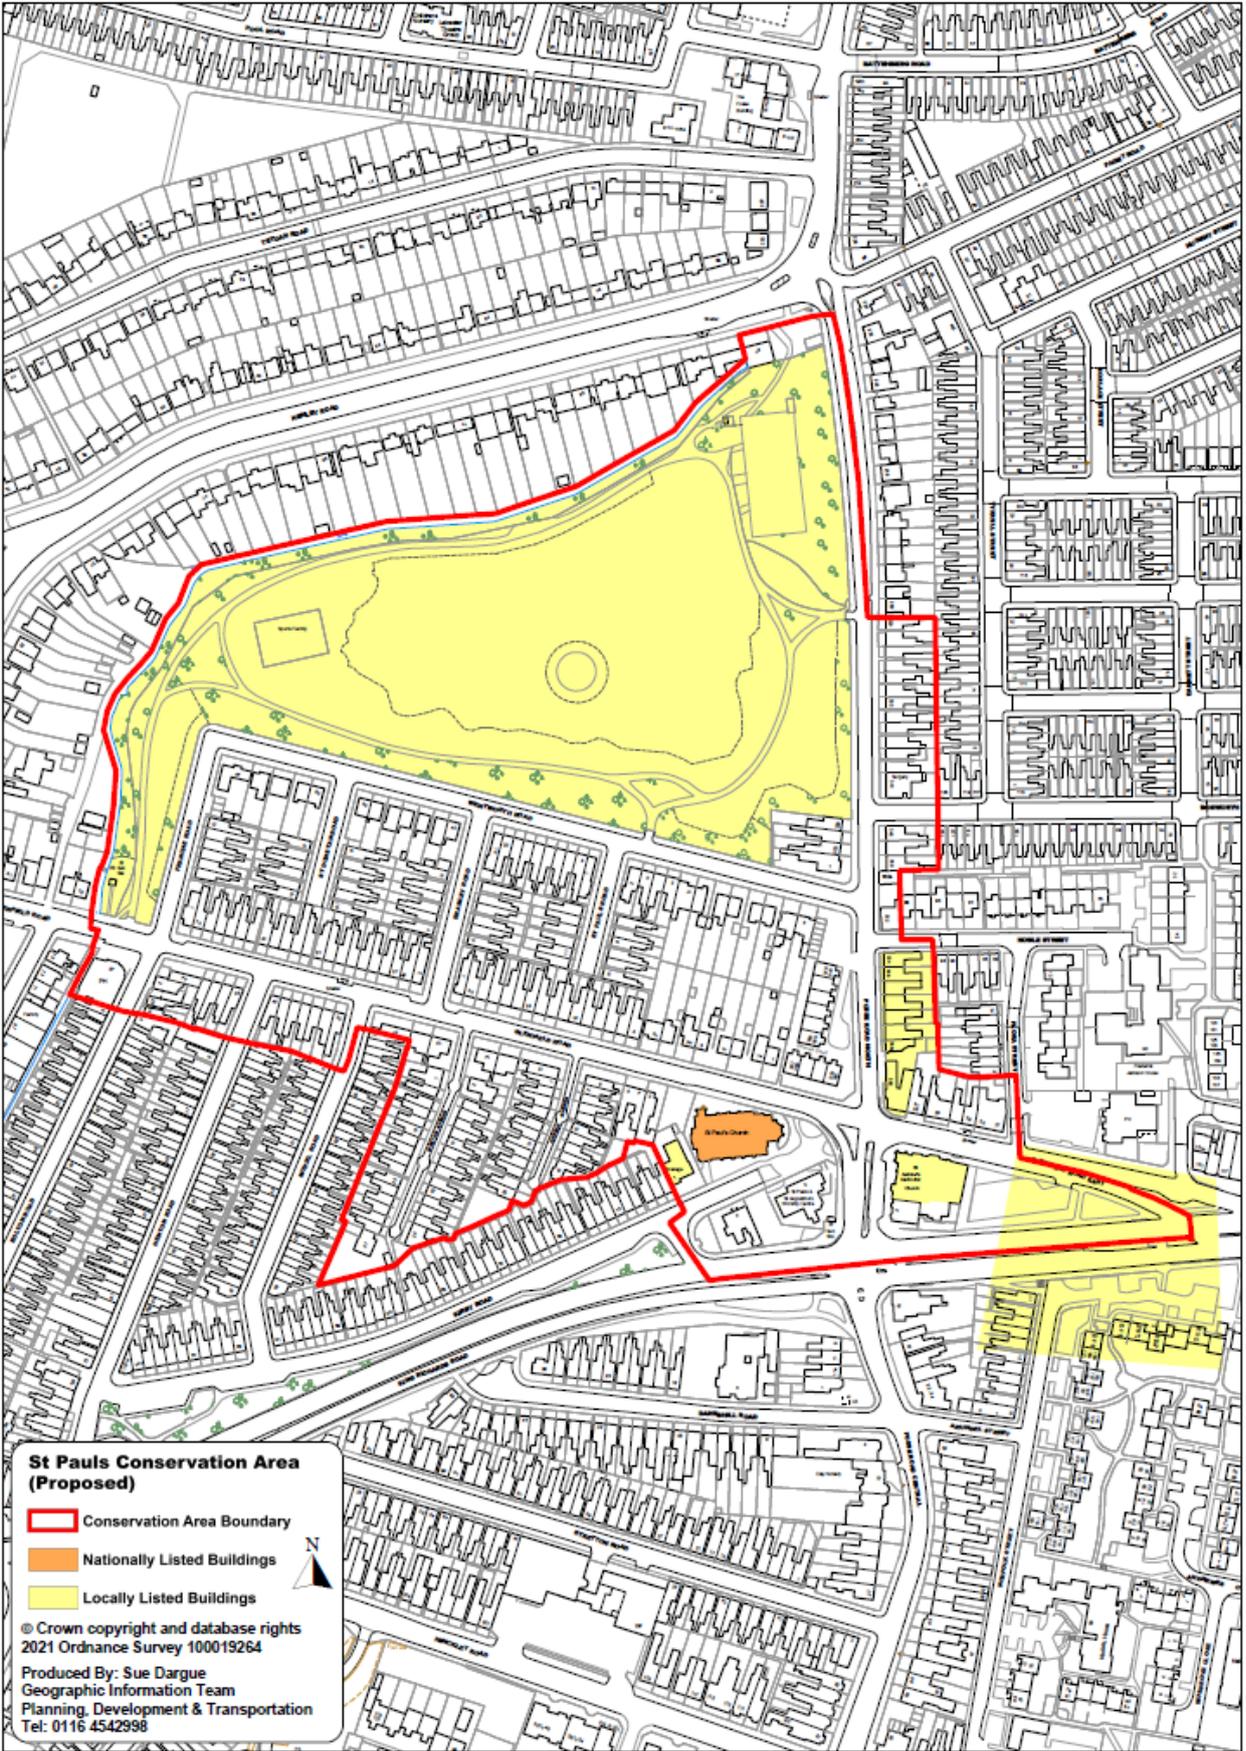
Figure 1: Map of the St Paul's Conservation Area.

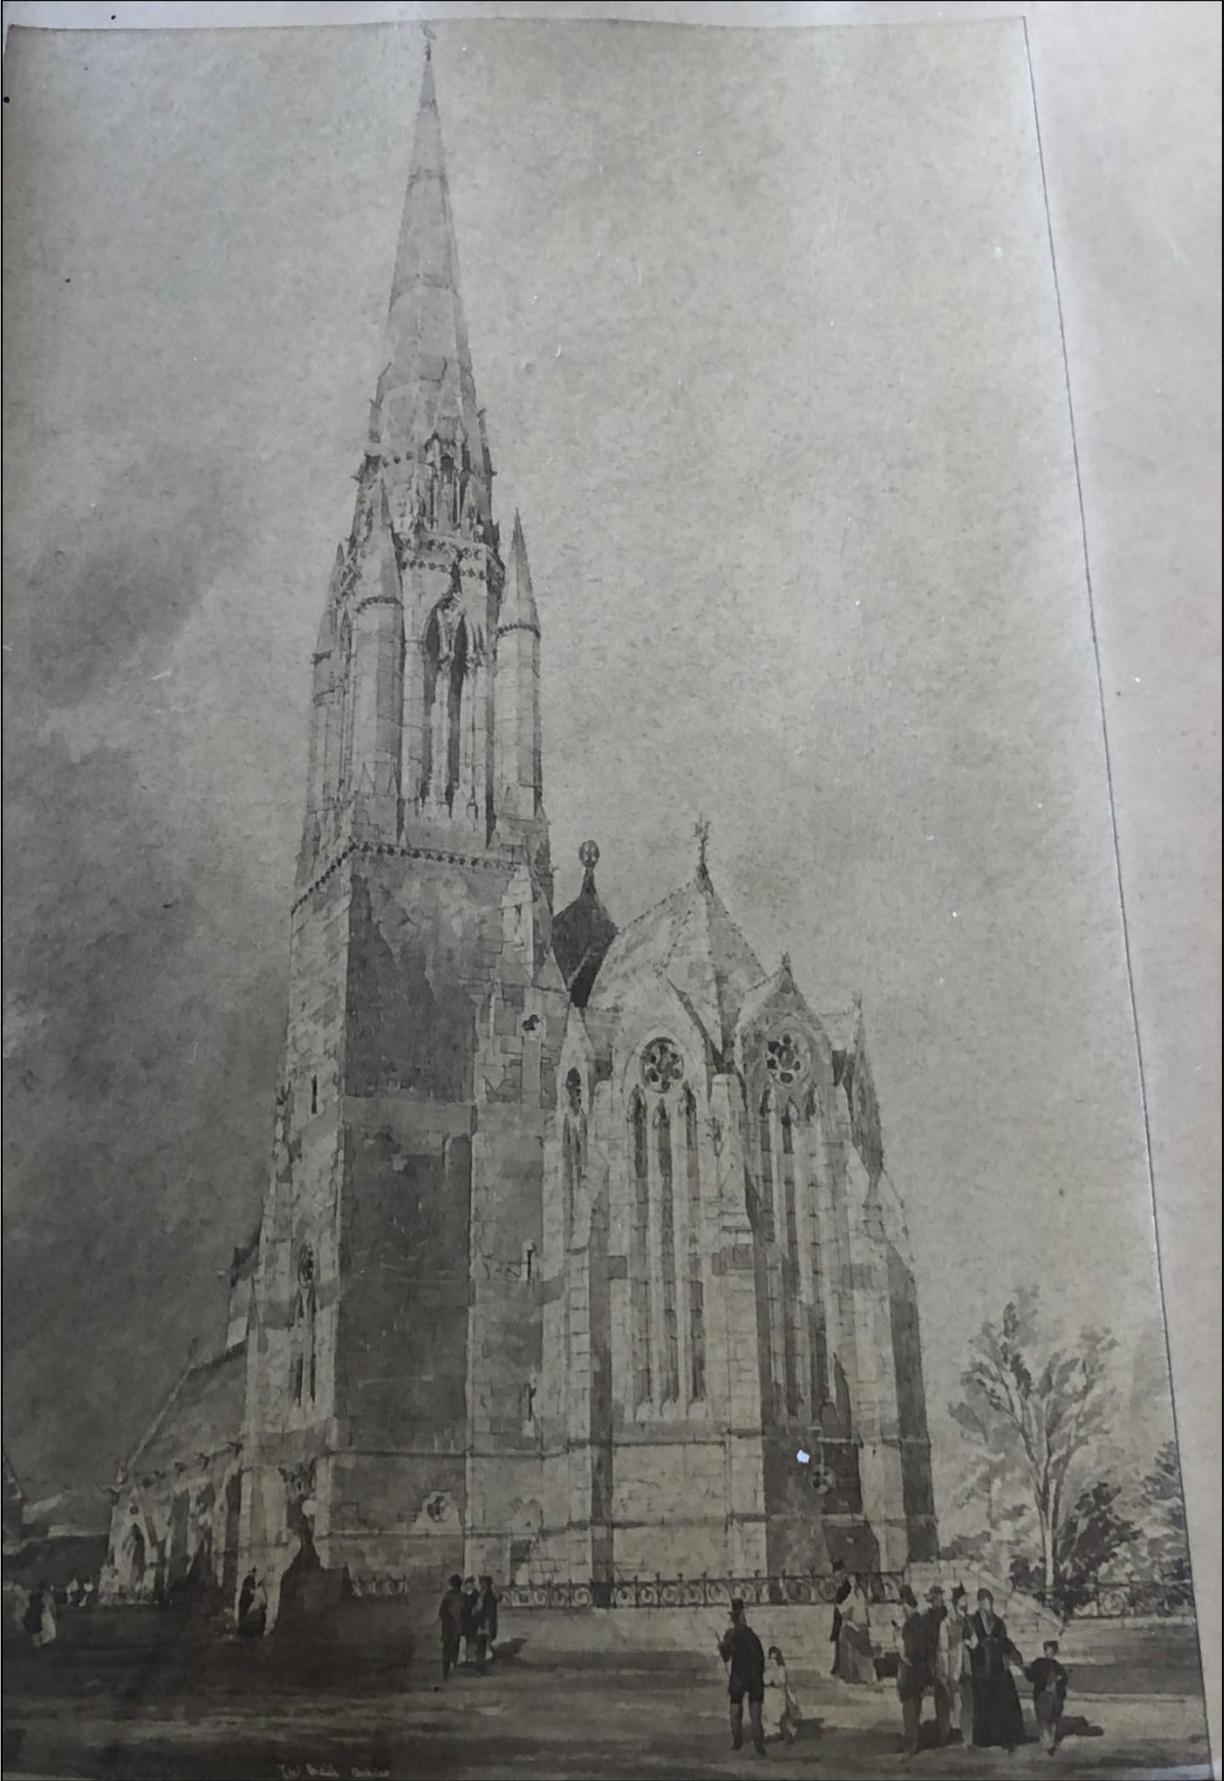
Figure 2: The Church of St Paul's as designed, 1870.

- 7.8. St Paul's Church was built around 1870. As originally commissioned, it should have been completed with a 190 foot spire. However previous excavations on the site made it impossible to bear such a weight and the tower was capped off at 62 feet.² By the early 1870s the area to the immediate east of the Church was developed, as the district of St Paul's, with new housing constructed on Fosse Road northwards up to its junction with the newly laid out Noble Street. By that time, the area south-west of the Fosse Road Recreation Ground was also developed. Around that time the Fosse Road Terrace at 354-364 and the Turret House were constructed.

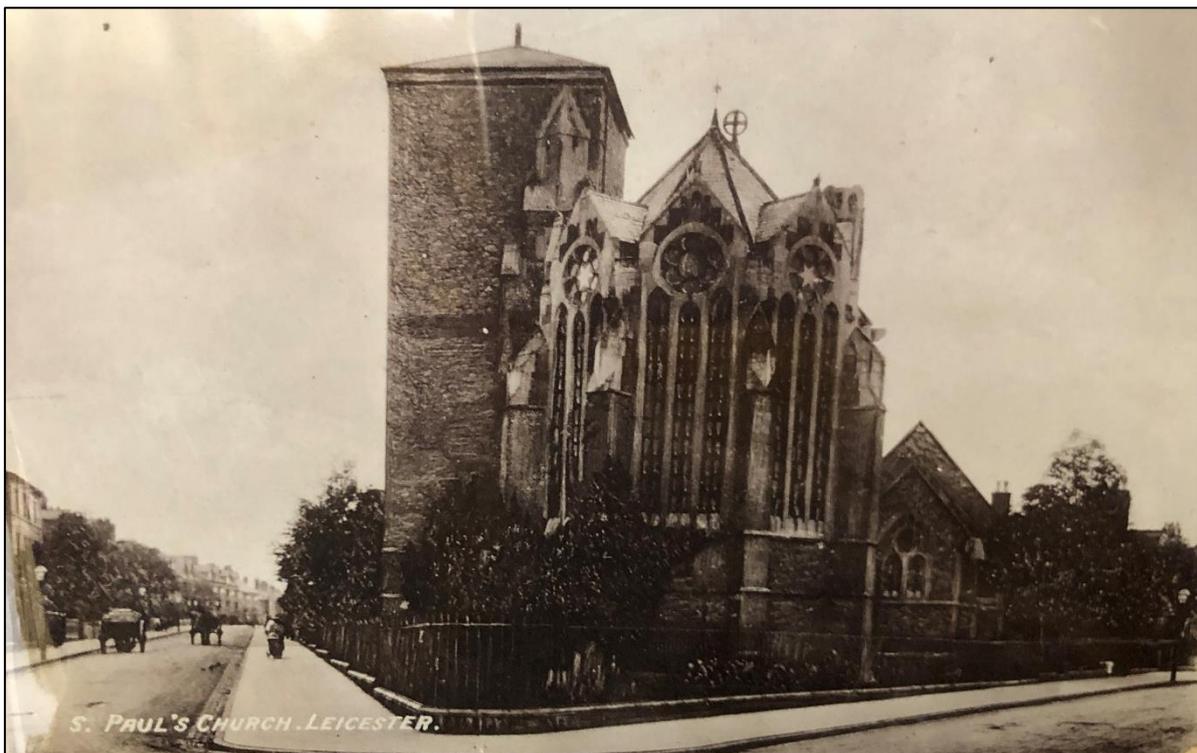
Figure 3: The Church of St Paul's as constructed, undated.

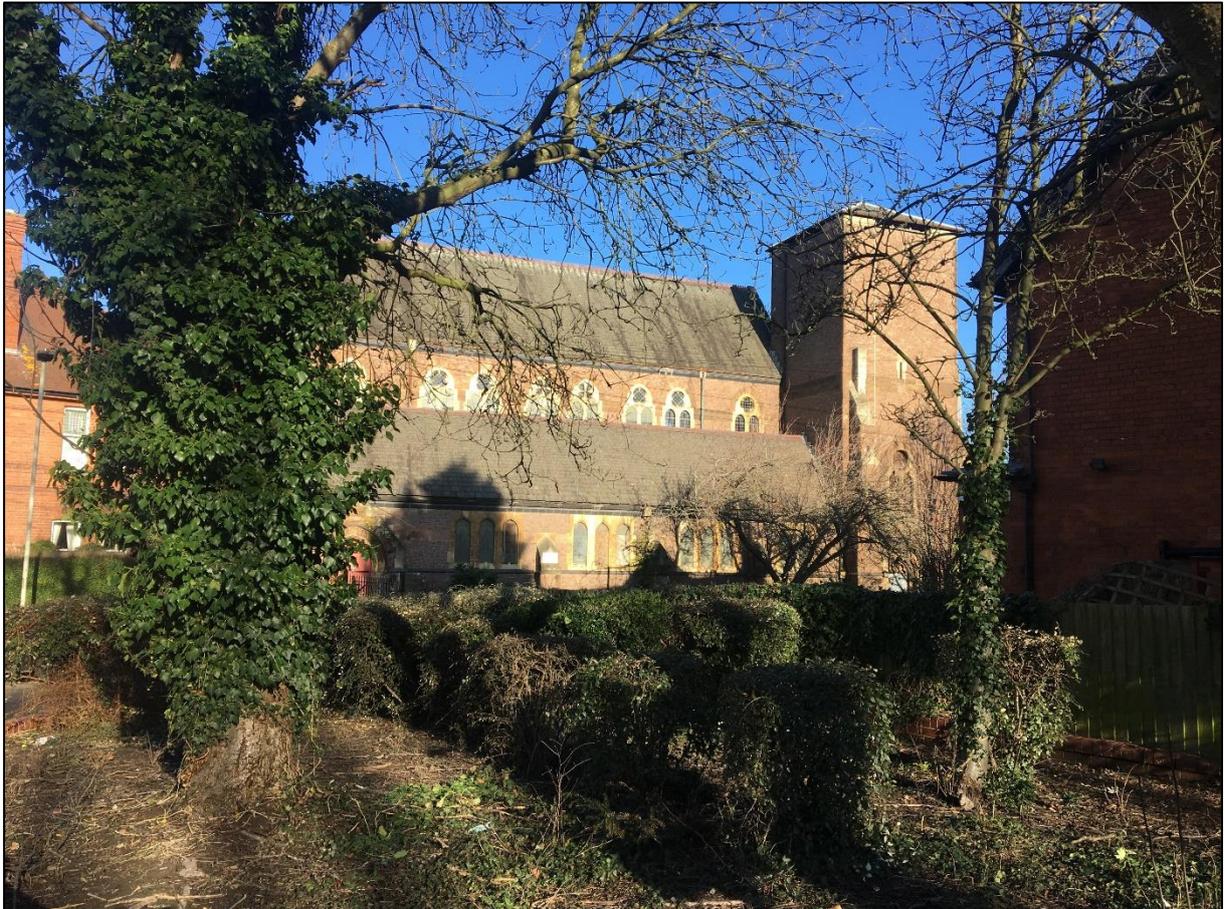
Figure 13: St Paul's Church, on the corner of Kirby Road and Glenfield Road.

enclave of historic buildings in this relatively sheltered location. Orientated towards Kirby Road, these buildings stand in contrast with St Paul's Church, whose positioning, facing onto Fosse Road Central, reflects its earlier date, pre-dating the construction of Kirby Road. The church is constructed in Mountsorrel granite with limestone dressing, in Early French Gothic style. The east end apse has five triple lancets each surmounted by a rose window under separate stone capped gable, with tall buttressing between. To the south of the chancel is a two-stage tower with hipped roof, the tallest element of the complex. The nave and aisles are covered by Swithland slate roofs, now in poor state of repair due to long-term vacancy.

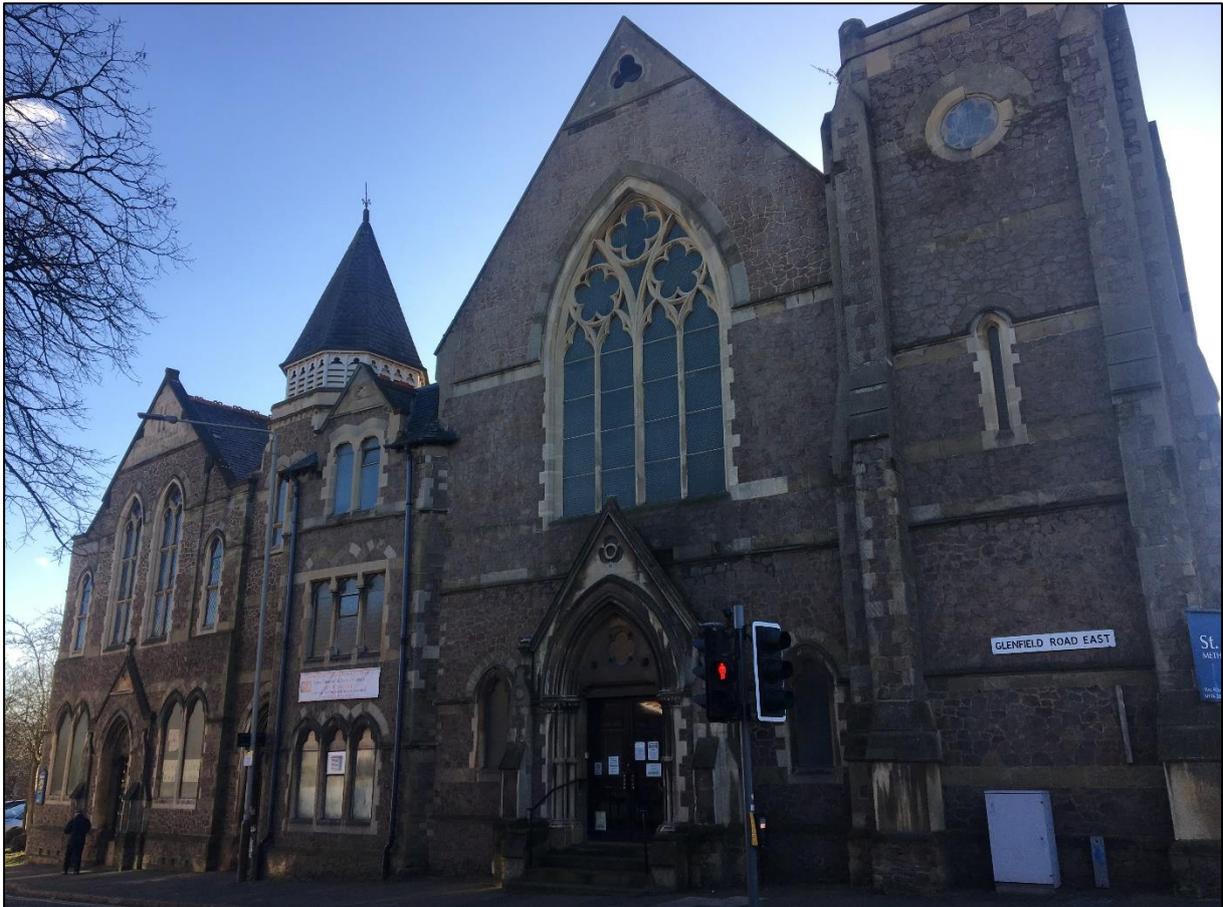
Figure 14: St Andrew's Methodist Church.

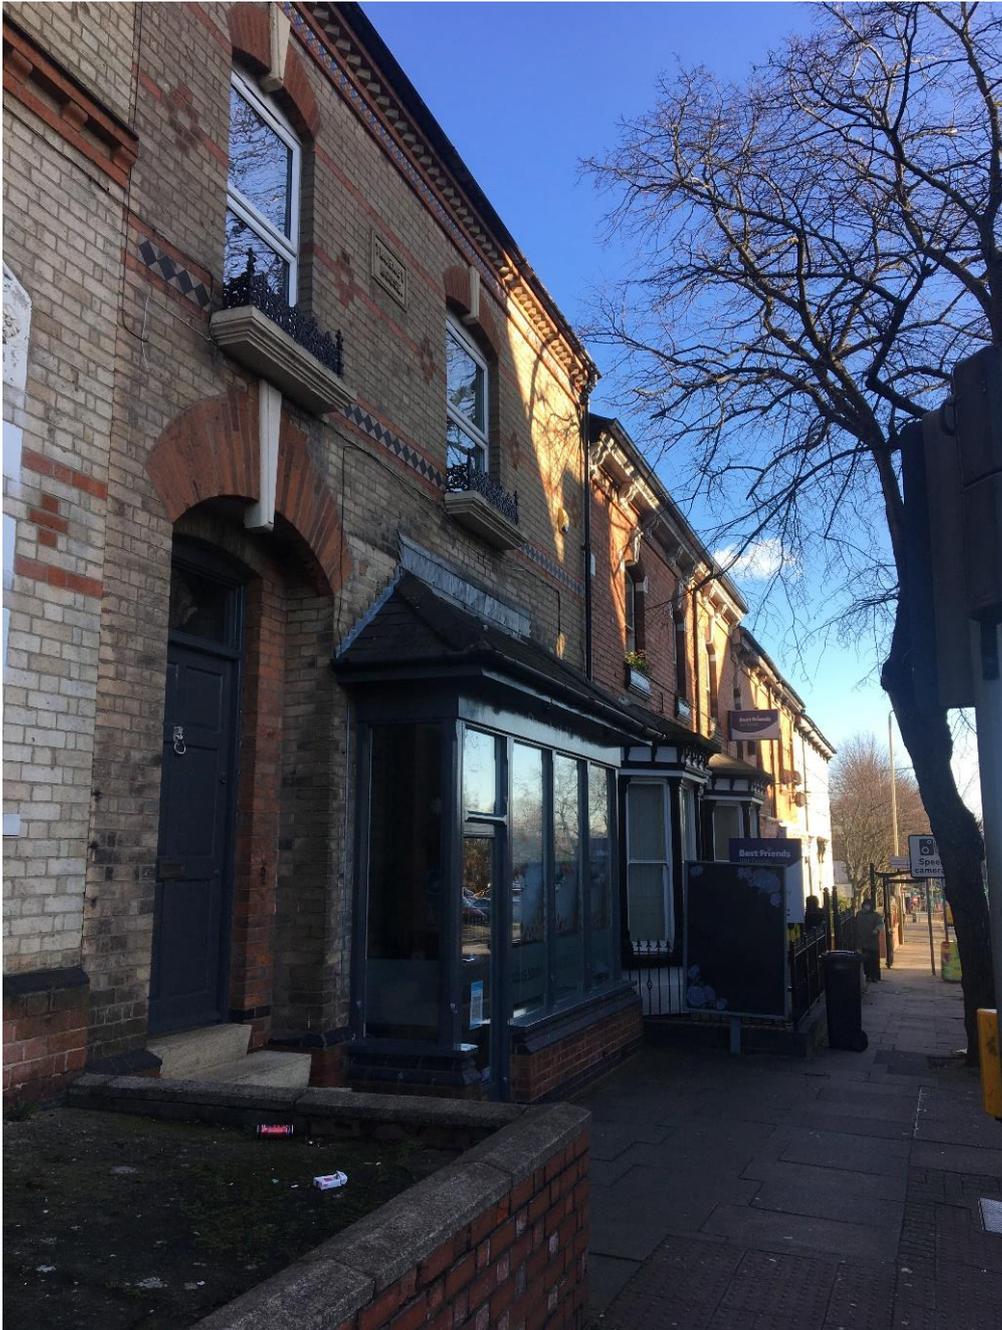
Figure 15: 21-33 Glenfield Road East, constructed c.1880.

- 9.6. To the immediate south, at the corner of Fosse Road North and Glenfield Road is the early 1970s Covent Court, set back on its plot. Directly opposite is the Fosse Road Terrace at 354-364 Fosse Road North, most likely constructed circa 1869 for C Stretton. It is a good example of a group of six late-19th century terraced properties constructed in a distinctive cream coloured brickwork, with Gothic detailing and ceramic tiled cornice. The properties are fronted by a modern but attractive front buff brick boundary with railings that runs through the whole terrace, contributing positively to the local streetscene and sweeping the eye along. To the south of the terrace is the former Turret House, now Estonian House, in 1878 recorded as being owned by Samuel George Dingley of Dingley & Sons. It is a good example of a dwellinghouse of this age & style, due to its high architectural quality prominent corner location. Similarly to the Fosse Road Terrace, it has been constructed in buff brickwork with ashlar and red brick dressing, with eclectic decorations in the form of ornate chimneystacks, diaper brickwork, stylized columns, colourful tiling and moulded brackets under overhanging eaves and polychrome pointed arched surrounds.

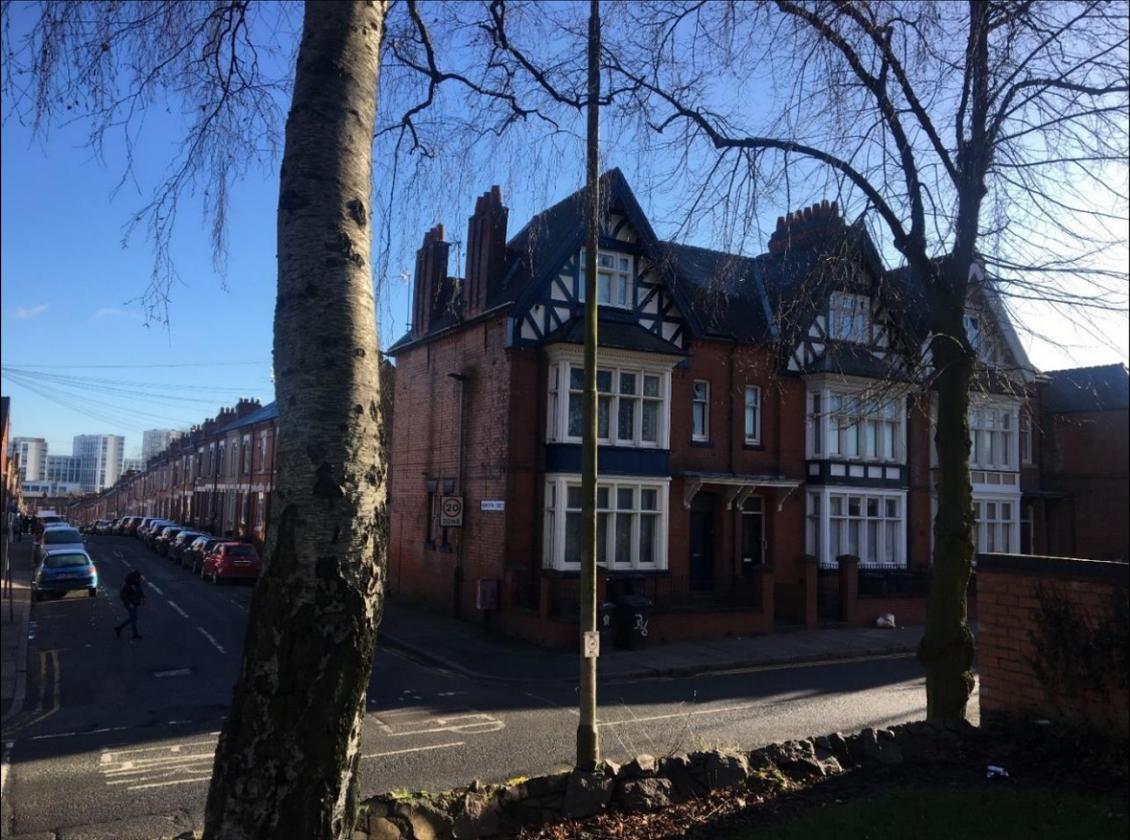
Figure 16: The vernacular revival properties at numbers 346-350 Fosse Road North, built c.1900.

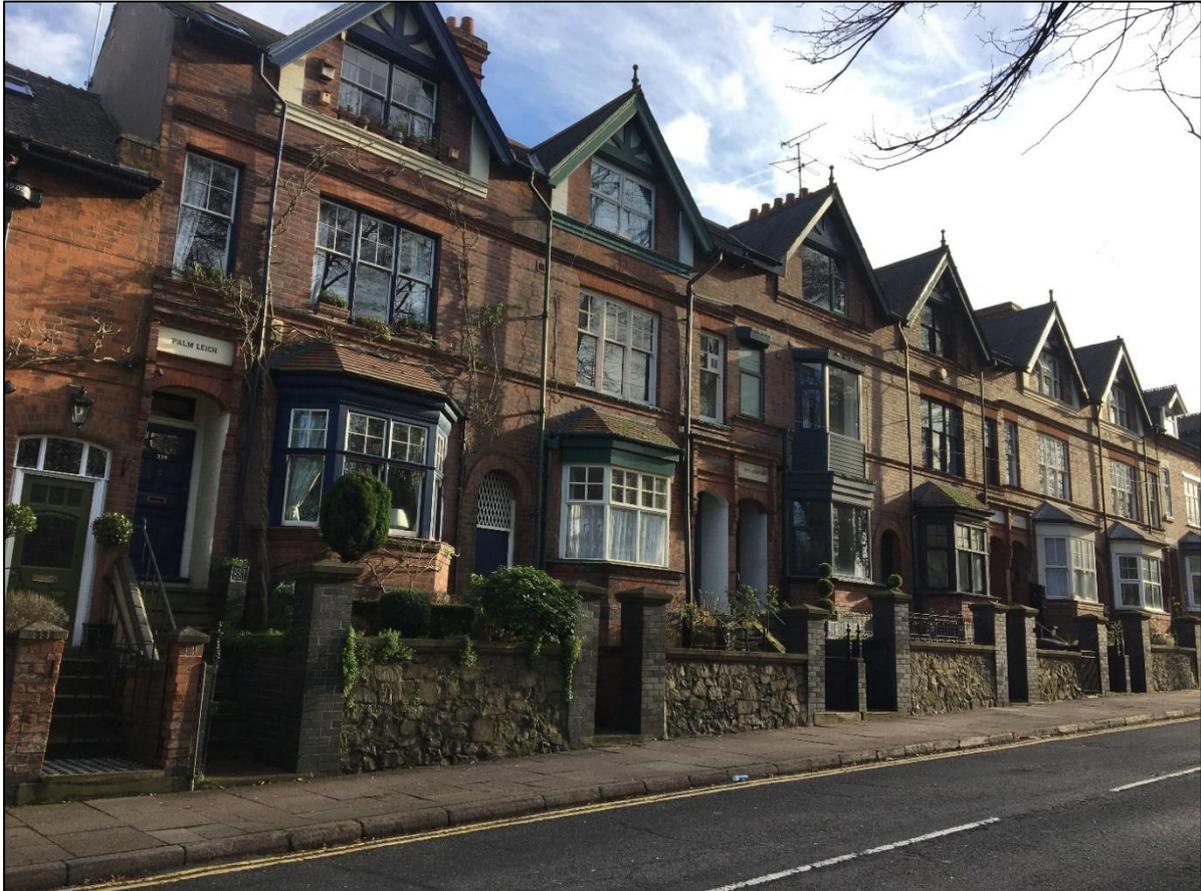
Figure 18: The canted bays and pointed gables of the dwellings at 320-332 Fosse Road North, creating rhythm in the streetscene.

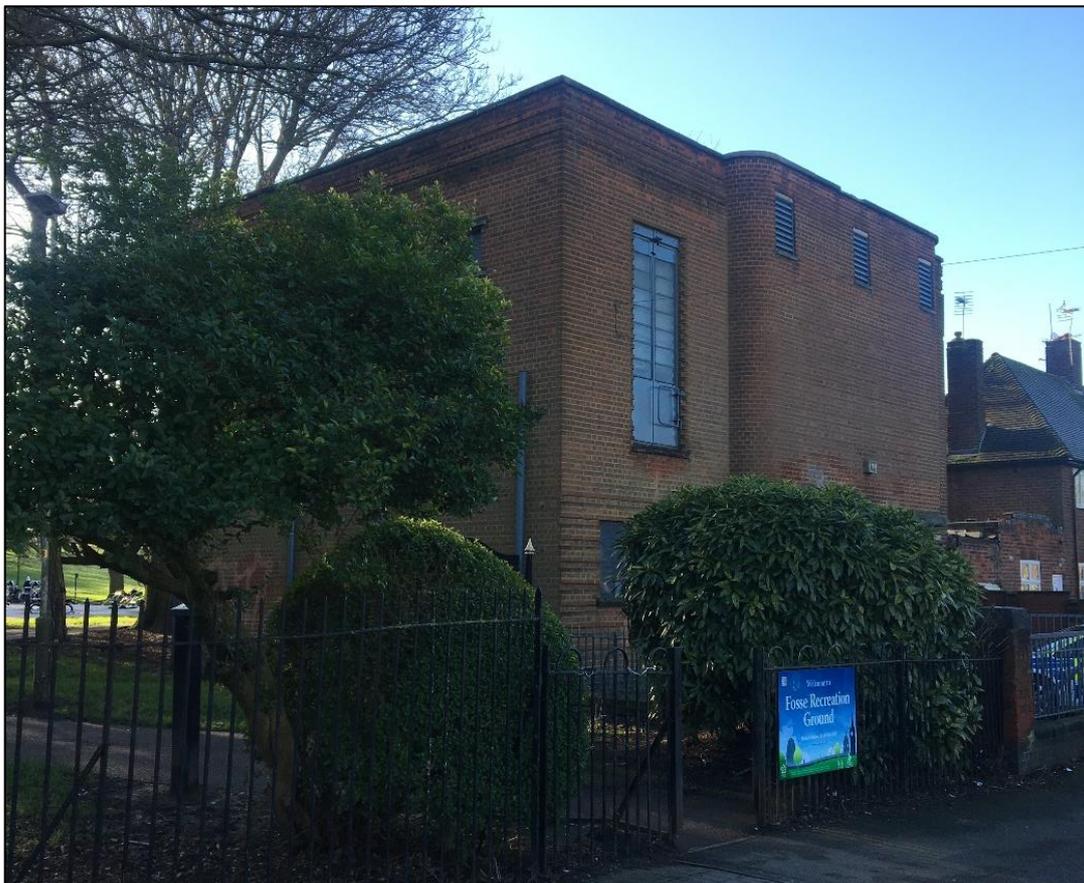
Figure 19: The 1930s electric sub-station on the north-eastern edge of the Fosse Road Recreation Ground. One of several sub-stations constructed in the inter-war period to serve the inner city and rapidly expanding suburbs, providing an electricity supply as it began to supersede gas as the main means of lighting.

- 9.10. The northern entry onto the Fosse Road recreation ground is guarded by a 1930s sub-station at 97 Henley Road. Constructed in brick, it shows clear Art Deco influences with a strong horizontal rhythm and curved corners.

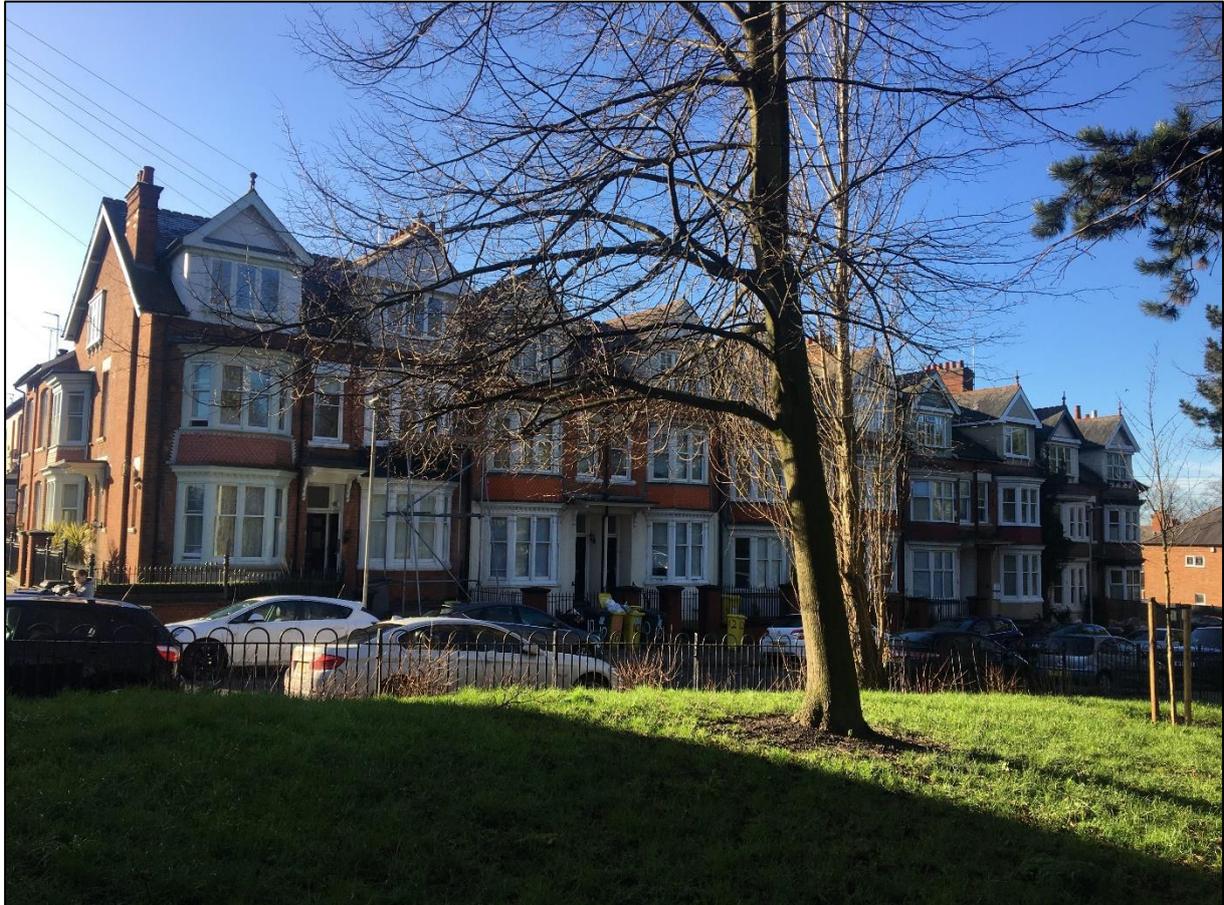
Figure 21: The dwellings at 8-22 Wentworth Road fronting onto the Fosse Road Recreation Ground form an attractive group and dominate local views.

9.13. Some of these features, alongside massing, height and finishes, are echoed in the ten villas positioned between St Paul's Road and Bramley Road. Constructed around the same time to the designs of the prolific local builder Cecil Ogden, the three storey terrace creates a prominent and well-conceived addition to the local townscape. Dwellinghouses in both groups are recessed on their plots, most retaining their brick boundary walls with railings, contributing to the definition of the public and private realms.

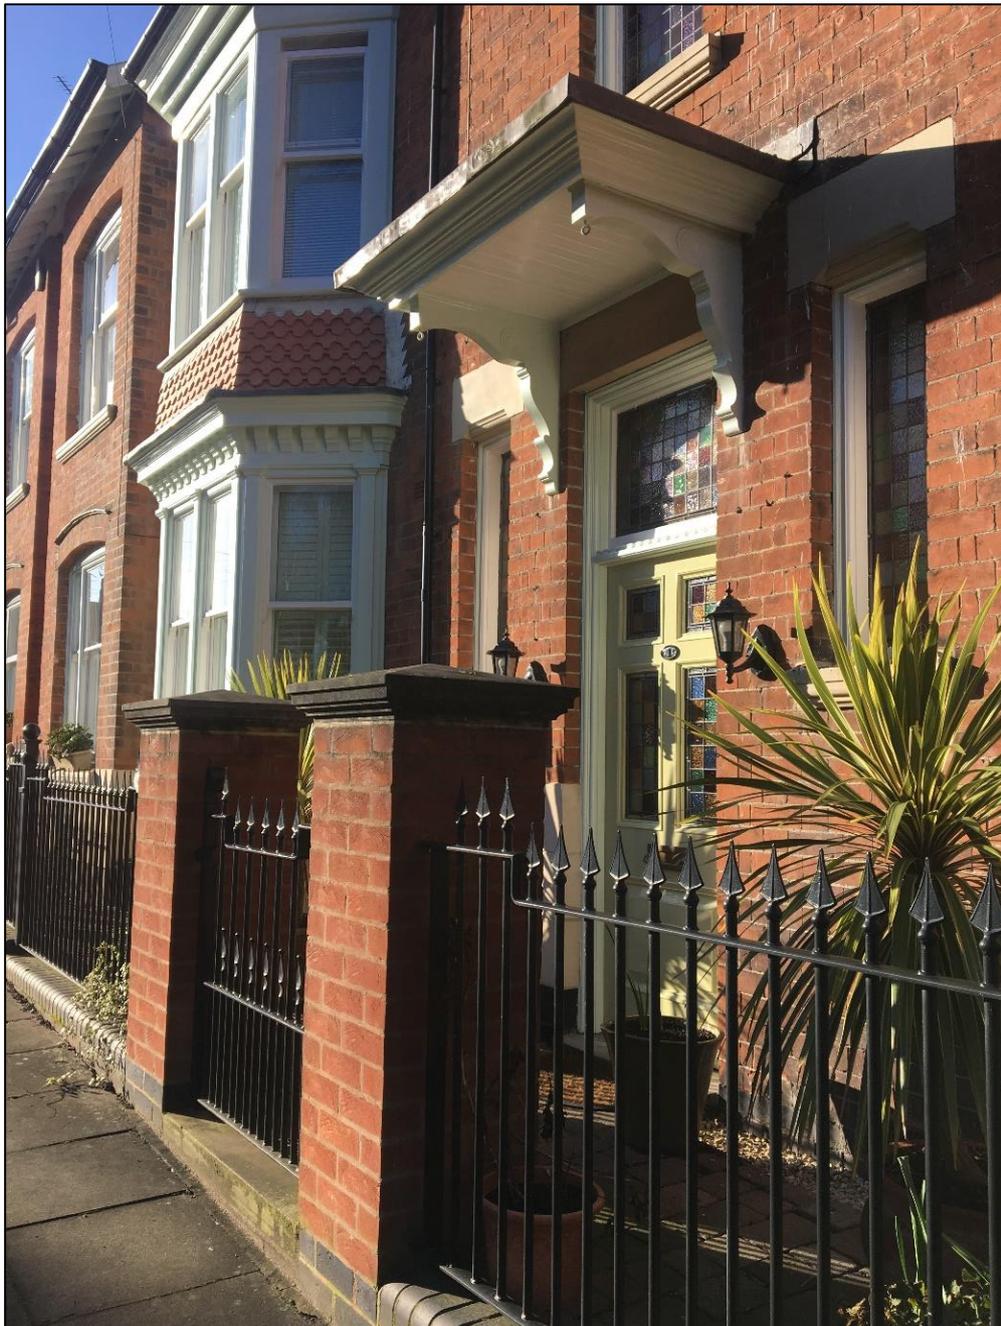
Figure 22: Fine detailing at the 'side' elevation of number 1 St Paul's Road.

9.15. The attractive side elevation of 2 St Paul's Road was already noted. This is counterbalanced by the attractive side elevation of the dwelling at number 1, echoing its neighbour's distribution of features and use of decoration, creating a conspicuous resemblance reinforced by the brick

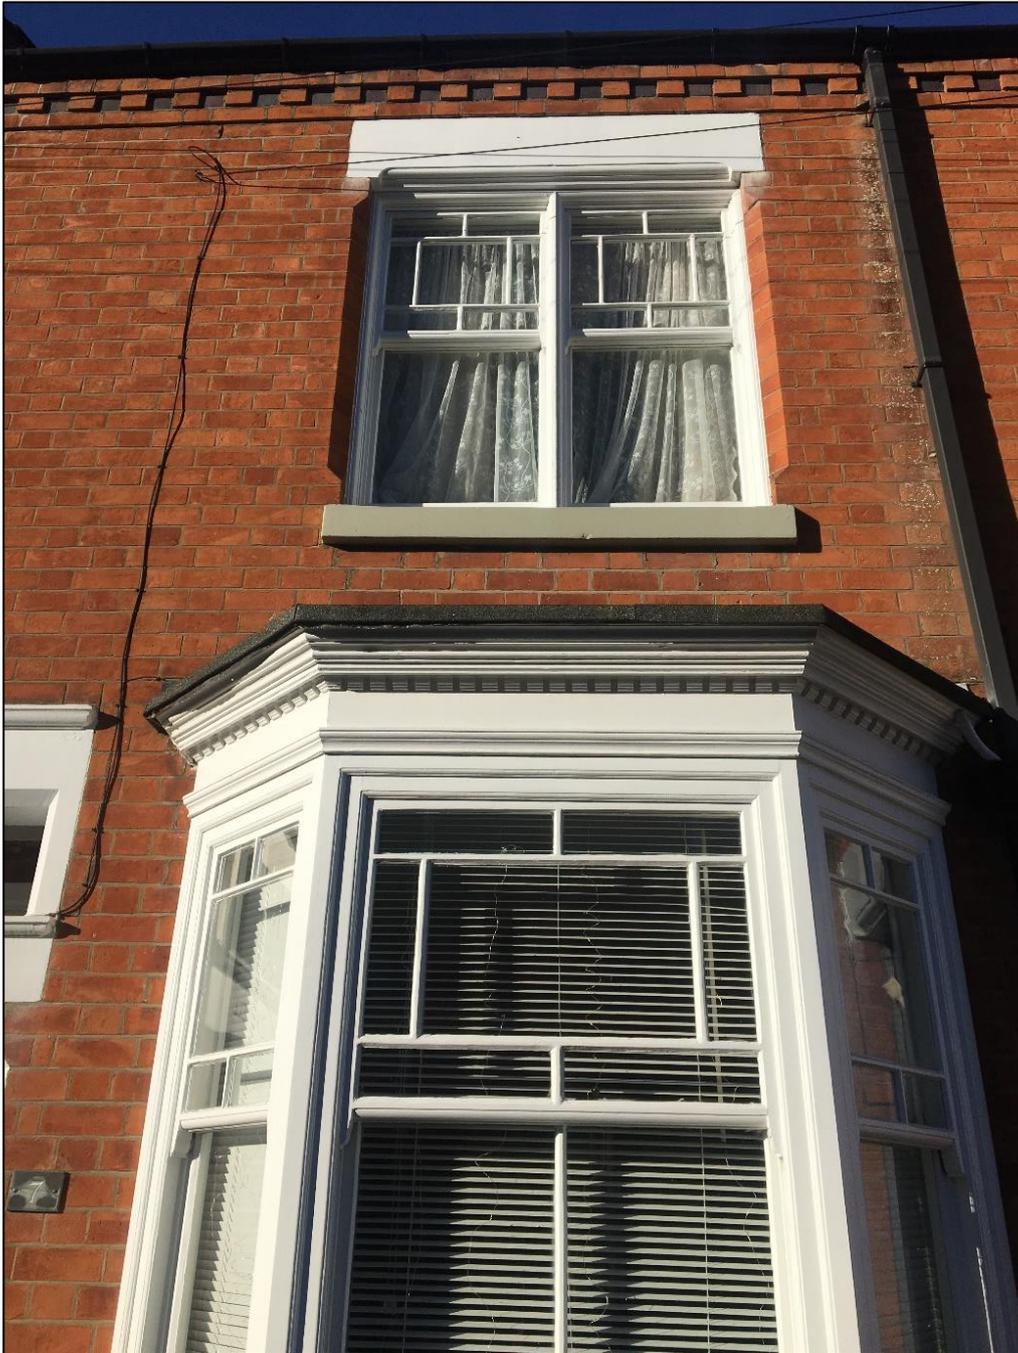
Figure 23: The original joinery to the front of the house at number 7 St Dunstan's Road.

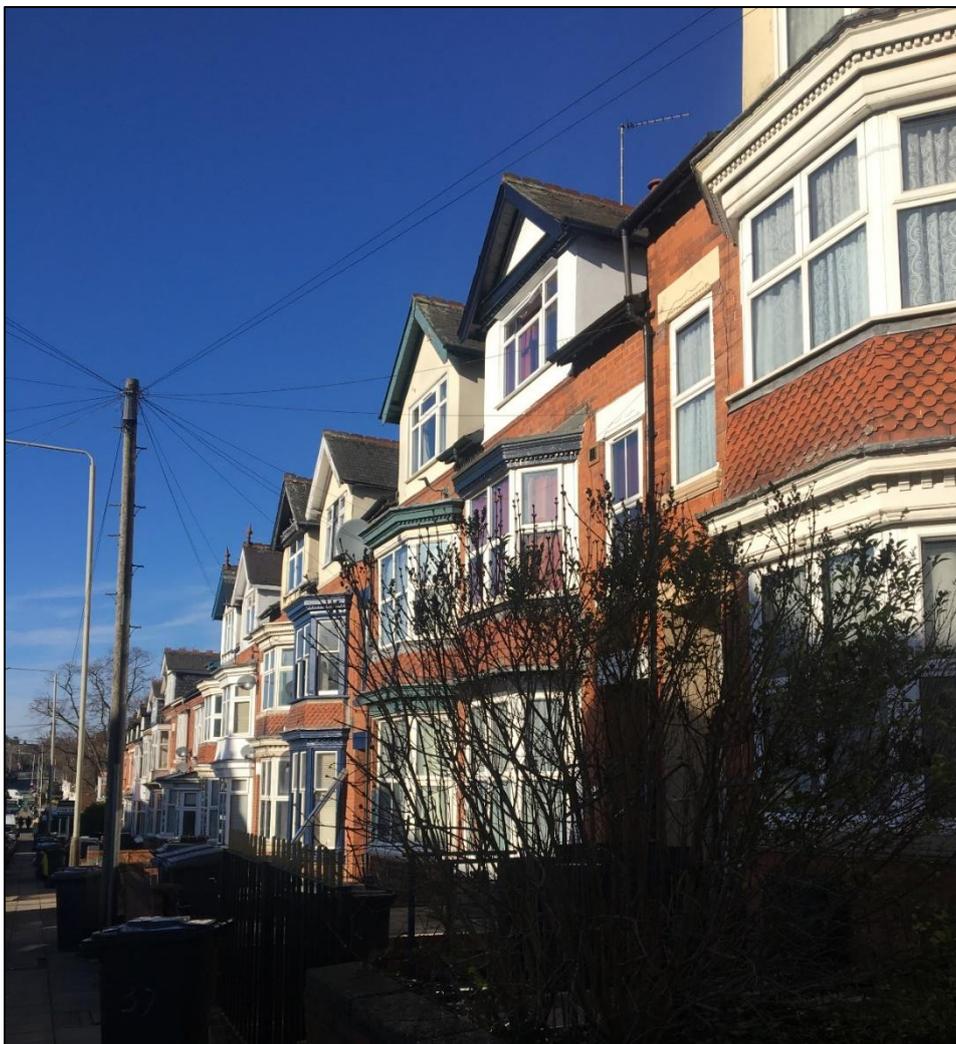
Figure 24: The large vernacular revival dwellinghouses along Glenfield Road dominate the local townscape.

9.17. Glenfield Road is dominated by the large three storey terraces concentrated on the north side. Set back on their plots, the buildings at 5-33 Glenfield Road each feature canted bays and a pair of dormers, creating a strong visual rhythm in the streetscene emphasised by the gentle westward elevation; this is in stark contrast to the two storey mid-20th century semis at numbers 1-3c, with a strong horizontality. The pedimented one bay dormers are particularly interesting, most picked up in white render. Unfortunately, all original windows and doors have been lost, some replaced by more sympathetic units than others.

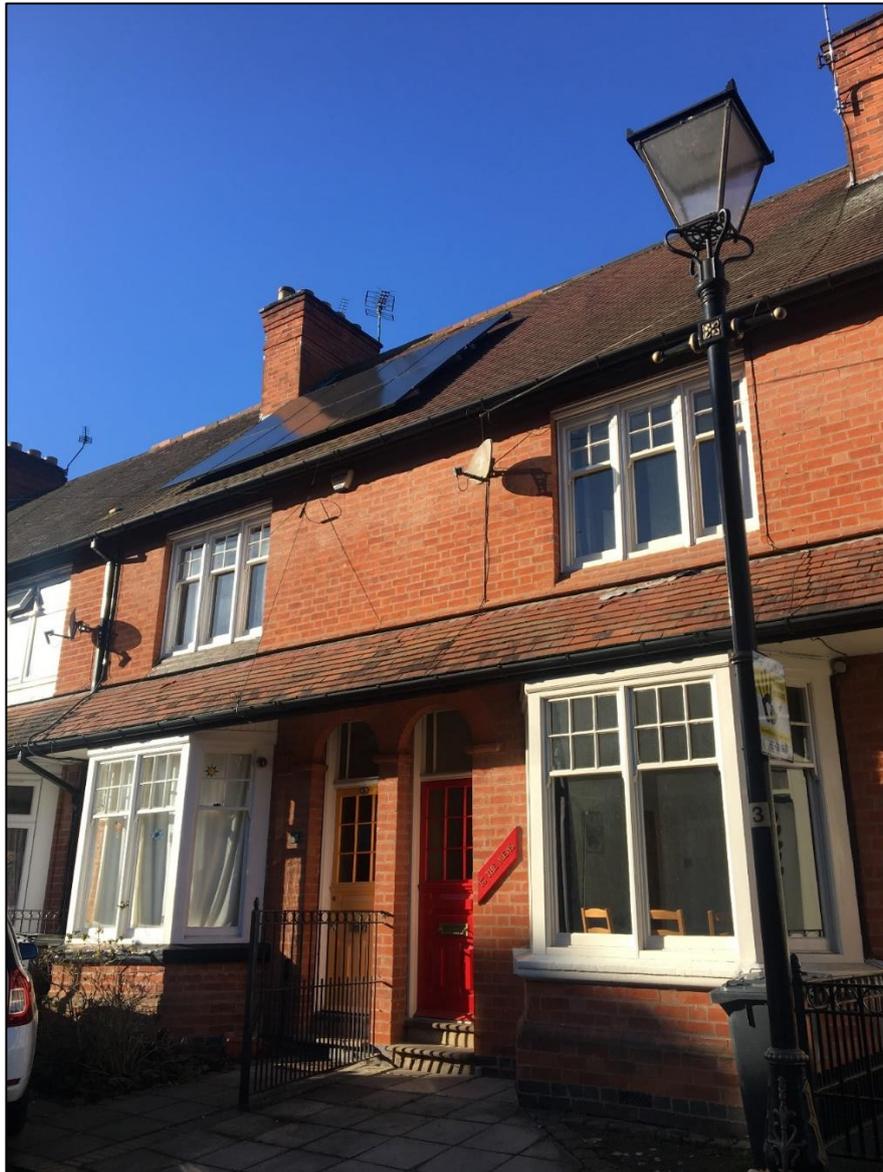
Figure 25: Merton Avenue, showing its cohesive terrace of two storey red brick artisan houses and the stylised iron lanterns.

9.24. Merton Avenue, constructed as Glenfield Avenue and renamed in the inter-war period, comprises of matching, simply detailed, two-storey brick dwellings with single storey canted bays under tiled canopies and arched recessed entrances. These dwellings were constructed around 1894 for J H Weston to the design of C Rempson. Few properties retain their original sliding timber sash windows and glazed, panelled timber doors. The chimneys animate the skyline, amplifying the uniformity of the streetscene.

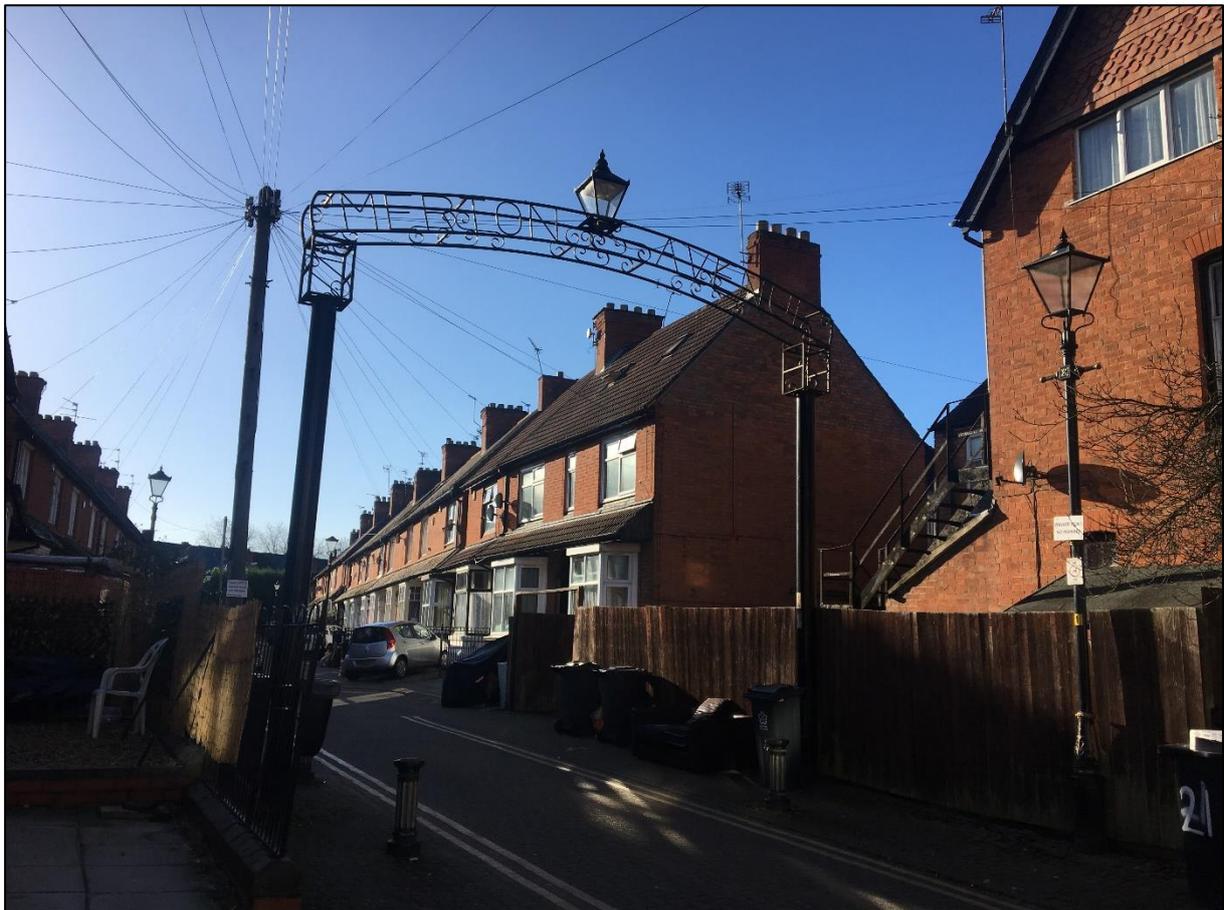
Figure 26: Formal entry onto Merton Avenue, with a decorative wrought iron overthrow on modern columns.

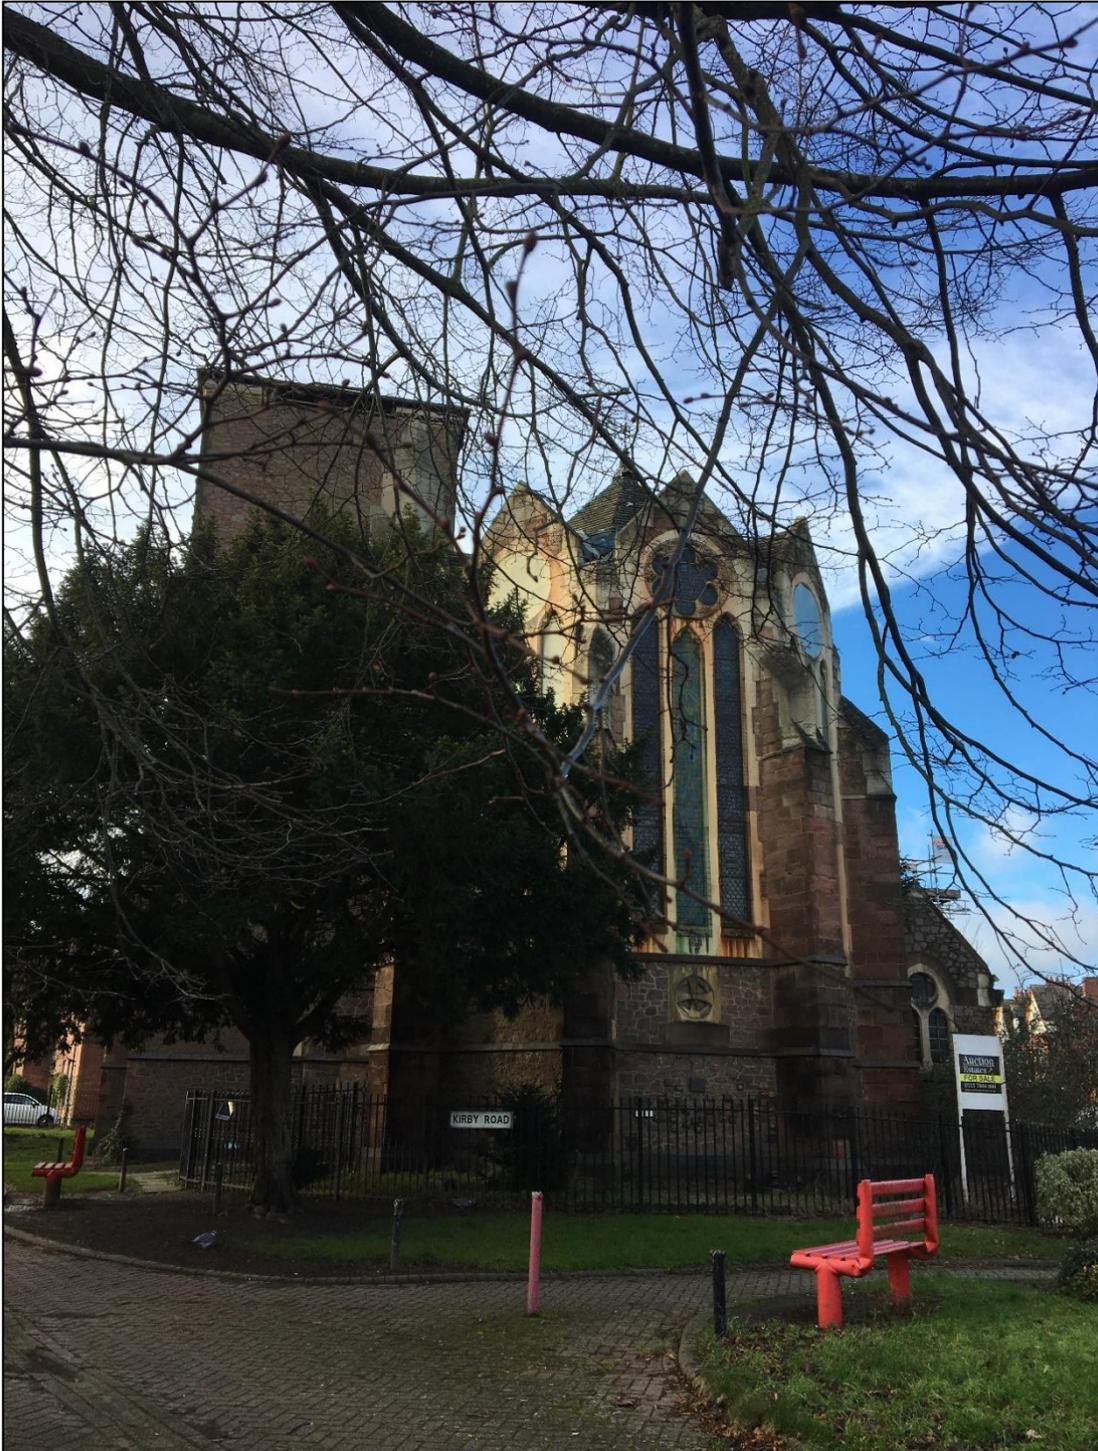
Figure 29: The Former St Paul's Church still visually dominates the area.

14.9. The condition of St Paul's Church is of particular concern. The building has been vacant since its closure as a place of worship in the early-2000s. Despite new ownership and an approved scheme for the conversion of the building to offices granted in April 2015, these works have failed to materialise, and the building remains vacant and at immediate risk of further decay. Its boarded up windows and scaffolding have a negative impact on the local streetscene and character of the area.
