St Paul's Conservation Area Character Appraisal

June 2022

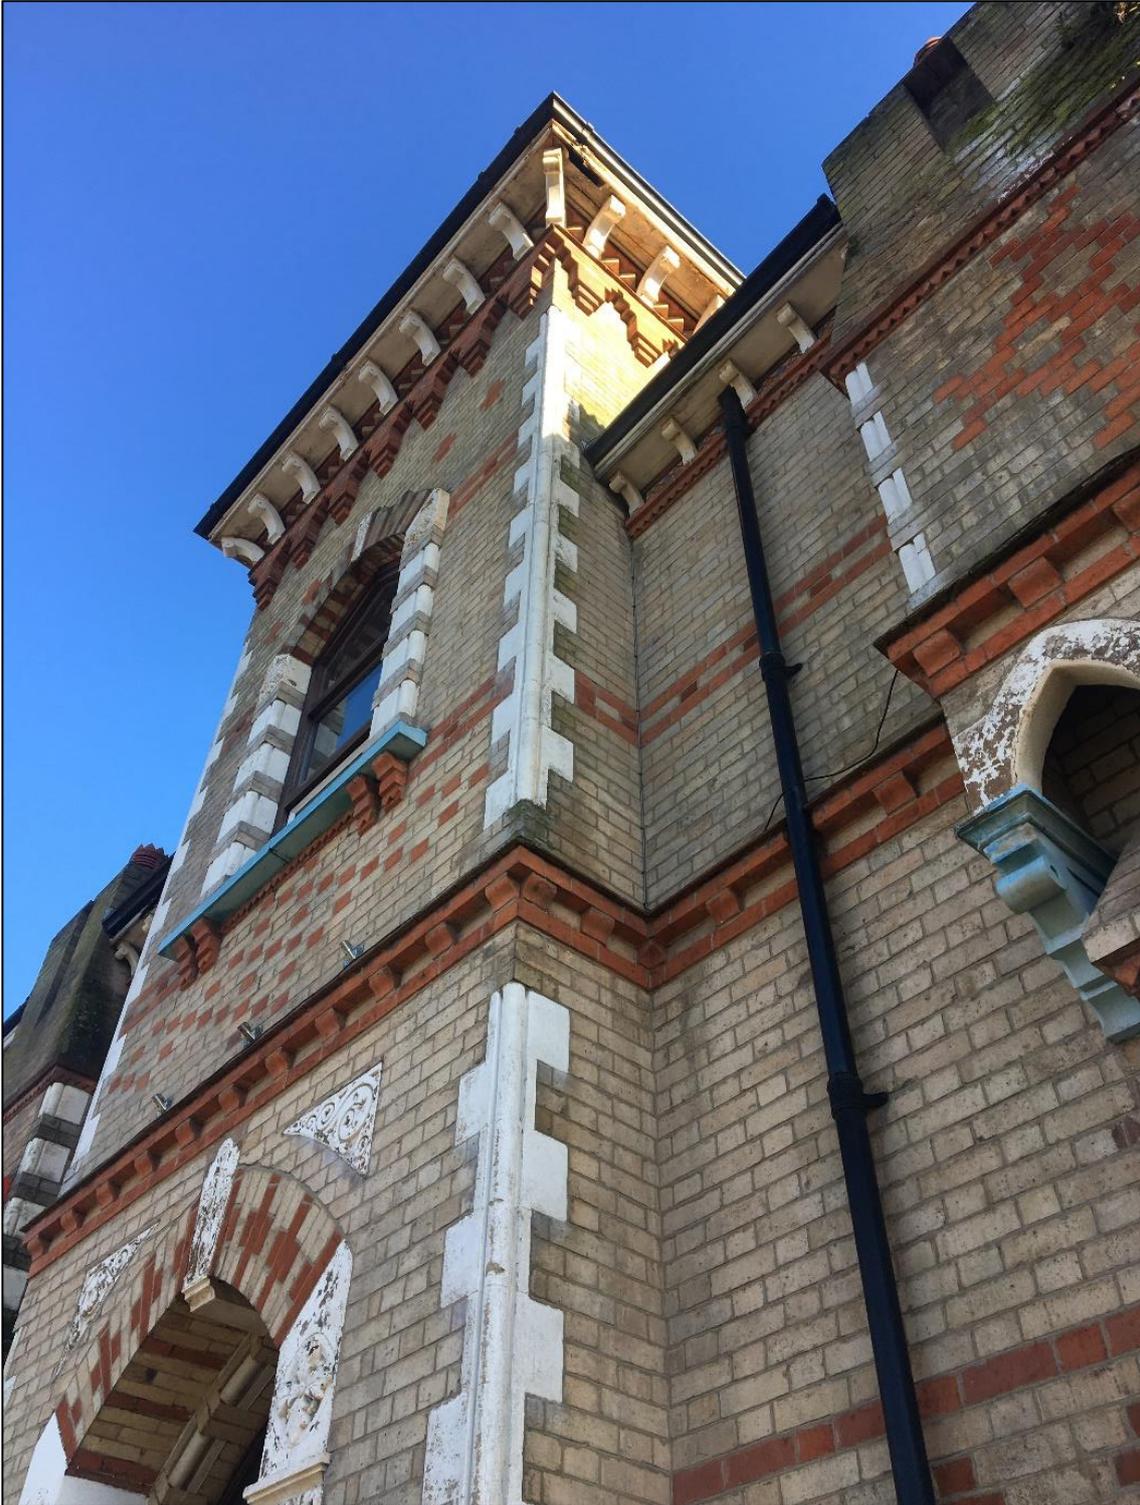
Figure 30: The buff brickwork is a somewhat unusual core building material in the area and highlights the status of the Estonian House.

11.3. Stone is used within the area predominantly as a dressing material, for windows and surrounds, eaves detailing, name plaques or porches. Decorative stonework can be found on a large number of buildings, with the Estonian House and the Former St Paul's Vicarage being notable examples. Former St Paul's Church and St Andrew's Church are the only buildings in the area constructed comprehensively from stone, that is Mountsorrel granite with limestone dressing.

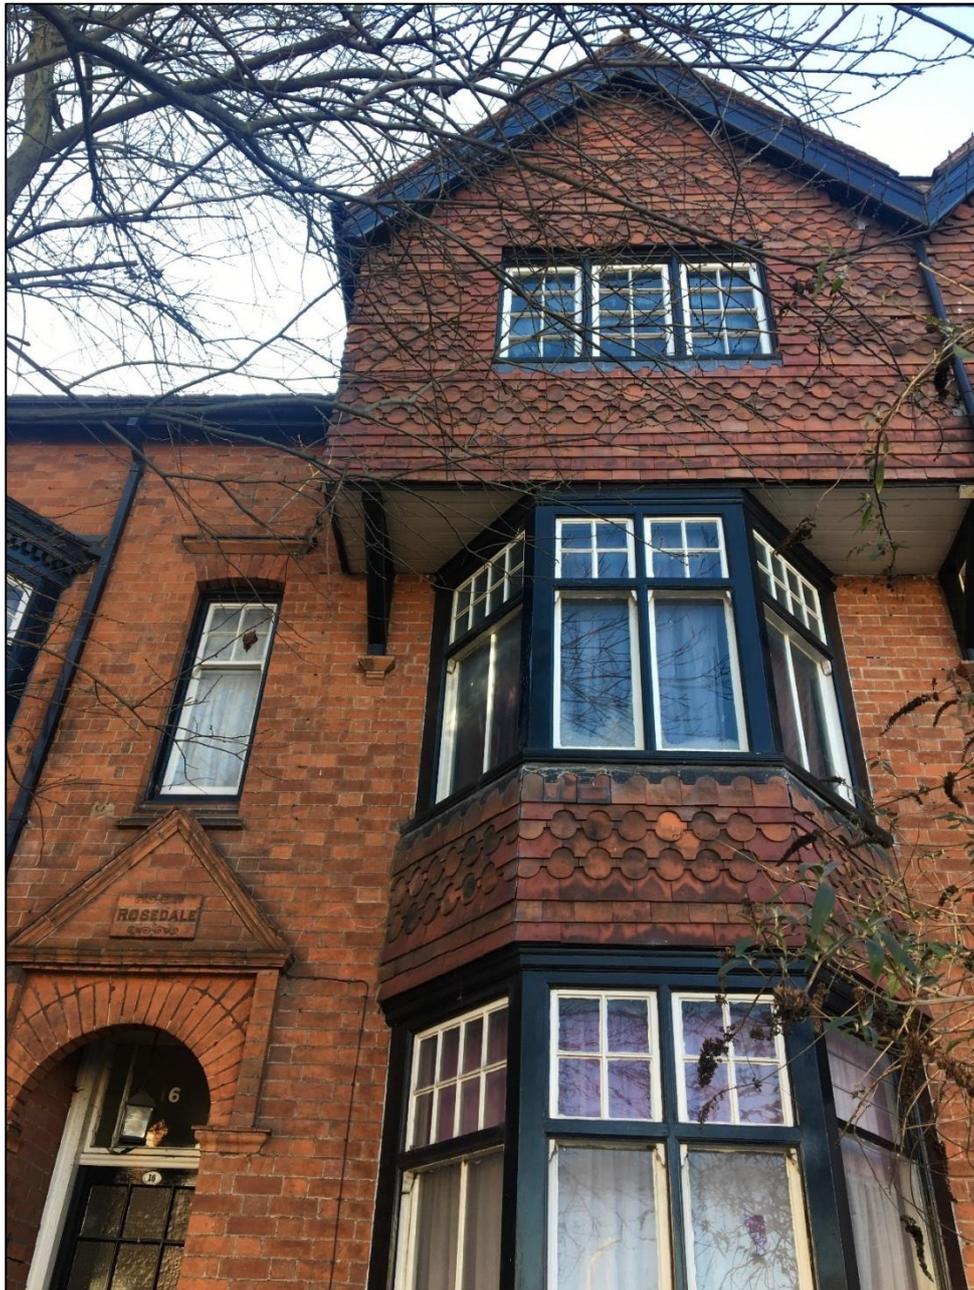
Figure 31: The hanging clay tiles and red brick elevations of the Rosedale villa make an attractive addition to the streetscene of the area.

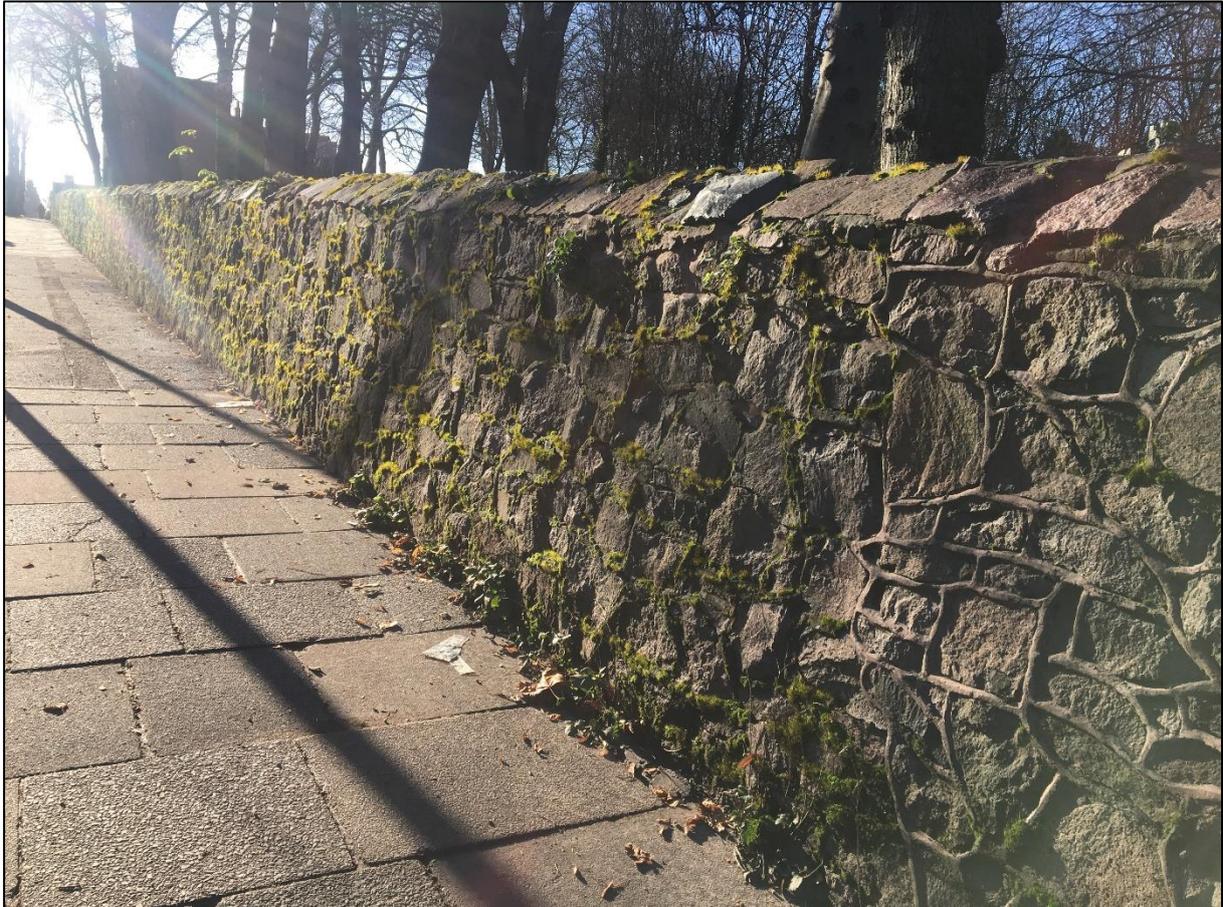
Figure 32: The Mountsorrel granite rubble walls enclose the east side of the Fosse Road Recreation Ground.

- 11.9. Mountsorrel granite wall defines a portion the eastern edge of the Fosse Road Recreation Ground, sweeping around onto Wentworth Road; the wall is complemented by the front garden boundaries of the dwellings opposite. Iron and steel railings are common, with steel hoop-top railings enclosing most of the Fosse Rod Recreation Ground, alongside the iron gates. Throughout the area, while few original boundary features survive, many of the stylised railings and gates, such as the arrow top railings along Wentworth Road, echo the original features and compliment the character of the area. Close-boarded fencing, timber panels and concrete bloc also make an appearance in the area as boundary treatments.

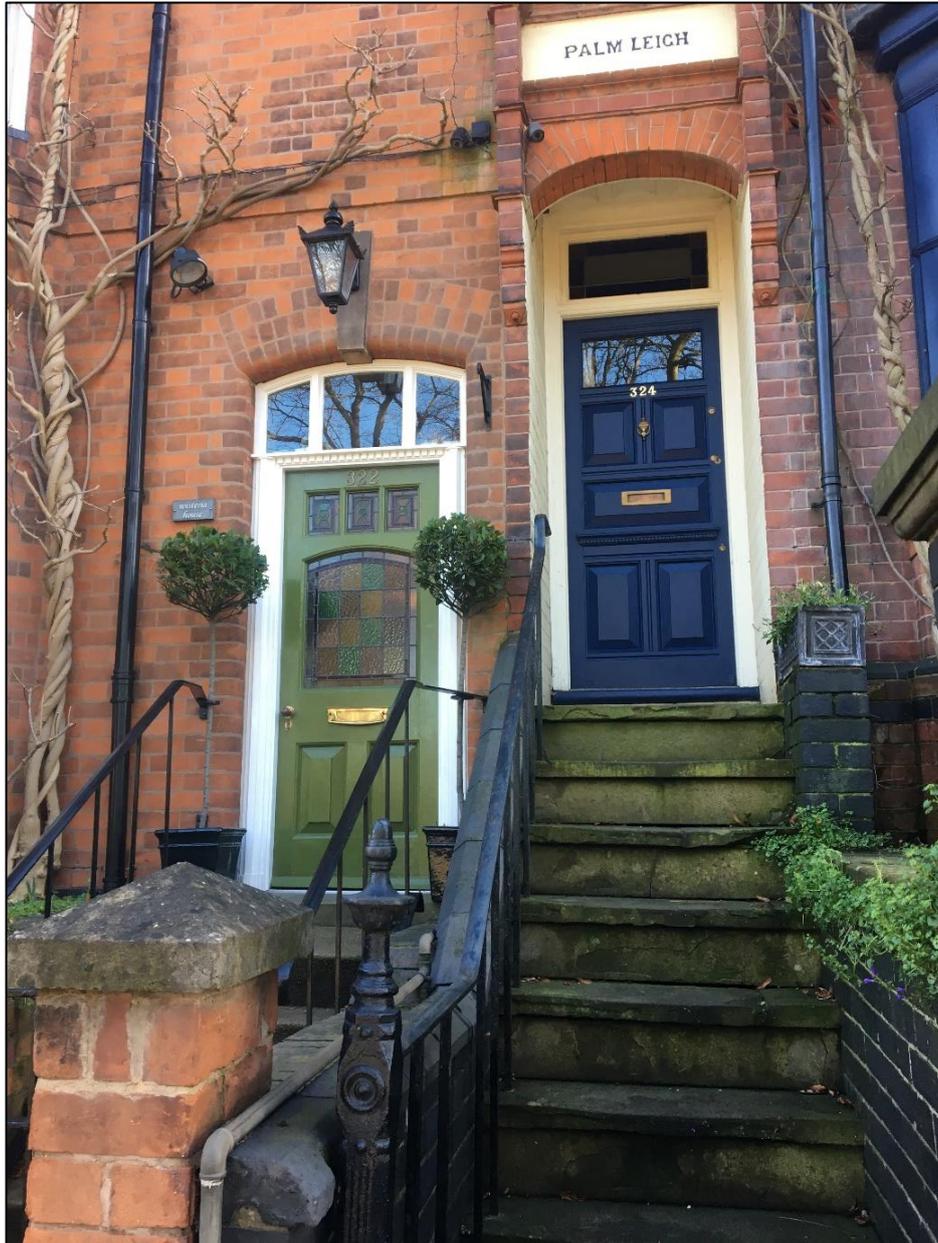
Figure 33: The original timber doorways at numbers 322 and 324 Fosse Road North contribute to the special interest of the area.

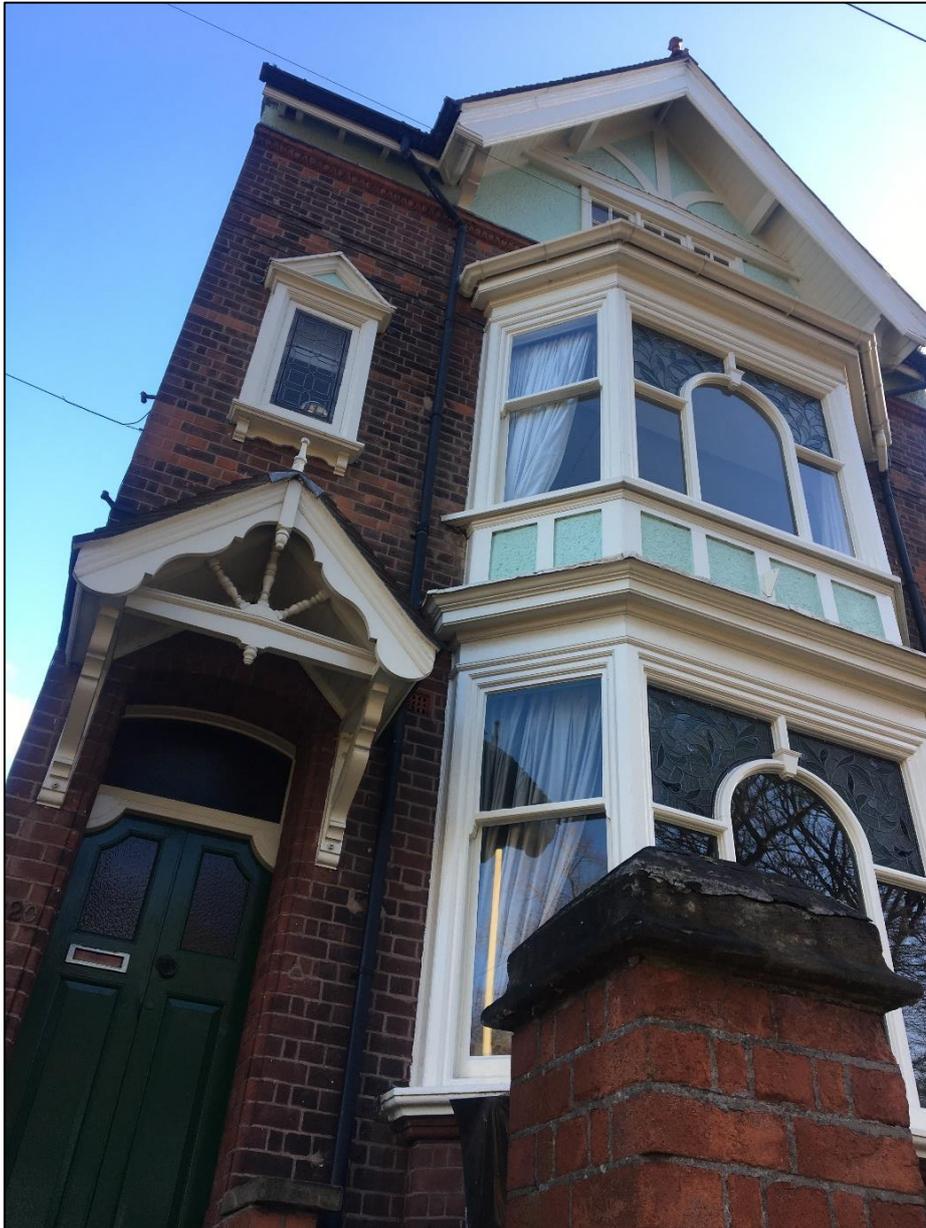
Figure 34: The original joinery at number 320 Fosse Road North is a rare and complete insight into the historic features that once decorated the frontage of a number of Victorian and Edwardian properties in the area.

most of the metal framed and leaded windows at St Andrew's Church and Former St Paul's. Timber gates remain at the side of 2 Bolton Street, Estonian House and 352a Fosse Road North. A few solid shutters have also been installed in the area.

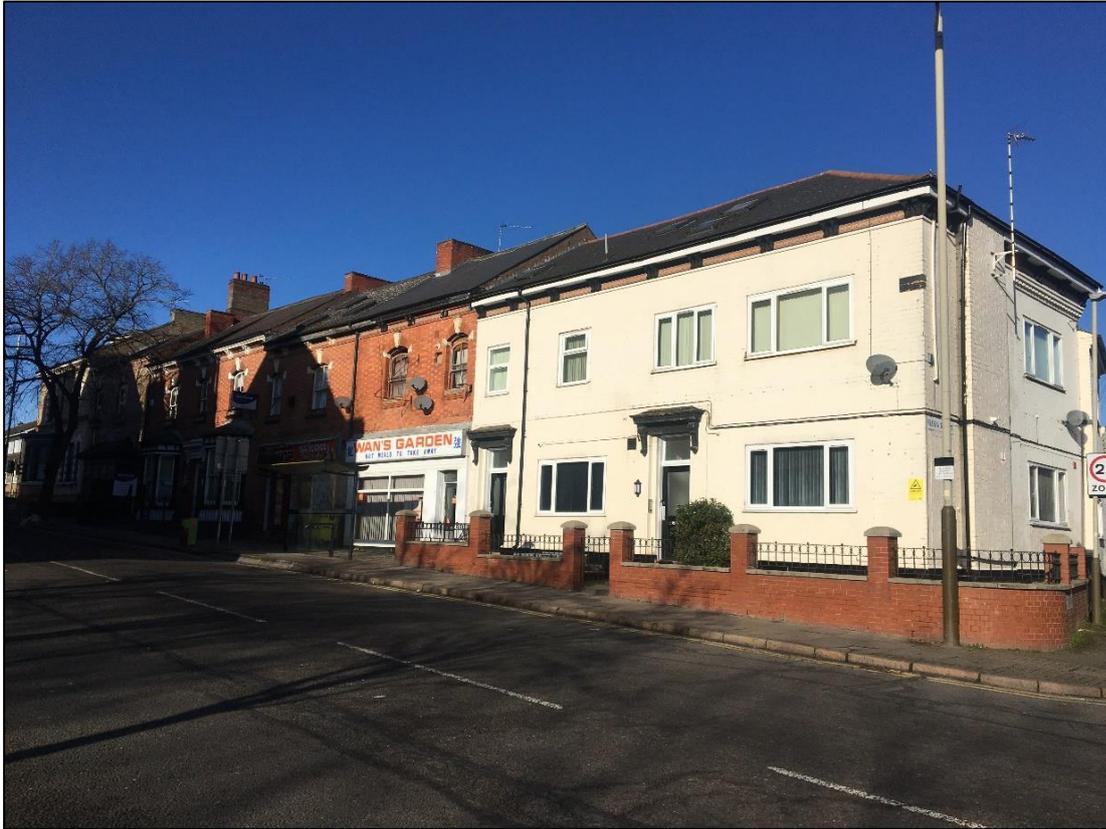
Figure 36: The painted elevations, poorly proportioned uPVC windows and satellite antennas at 21-23 Glenfield Road East have negatively impacted on the character of the area.

14.1. The greatest erosion of character in the Conservation Area has been the replacement of original features, such as windows and doors. In most cases, the fine detail, proportions and quality of the originals have not been adequately replicated. Plastic windows and doors have had the most adverse effect on the streetscene and architectural interest of the area. Otherwise, the adverse long term impact of the mock non-structural glazing bars is exemplified by the failing joinery at 352a Fosse Road North.

14.2. The painting, rendering and cladding of frontages has also had an accumulative negative impact on the character of the area. External treatment can hide decorative brick patterns and finishes and result in on-going maintenance requirements. The application of non-breathable paint and cementitious render can also cause damage to the brickwork where it traps moisture.

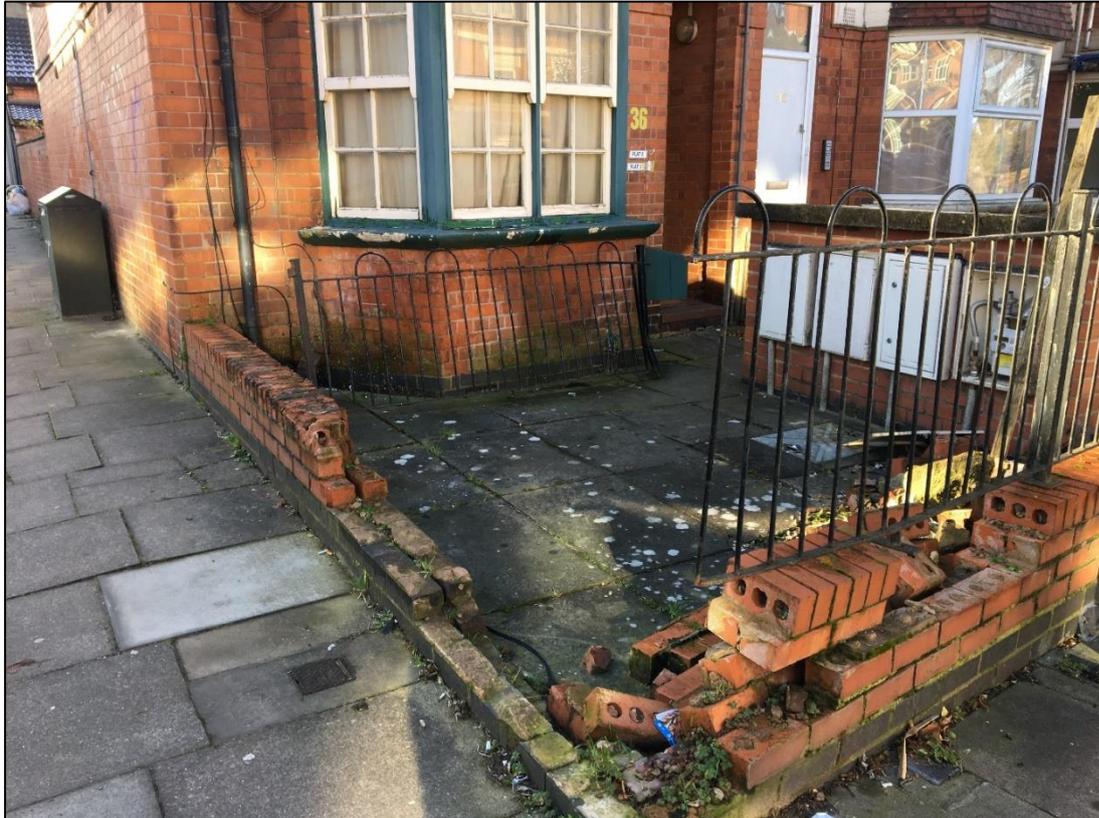
Figure 37: The damaged front brick wall at the corner of Henton Road and Glenfield Road.

14.5. The loss of front boundary walls to provide forecourt parking harmed the historic character of the area and the quality of the townscape. The streetscene of Glenfield Road is particularly disjoined as a result of the removal of front boundaries, in places dominated by tarmacked or paved hard landscaping. The installation of poor quality timber fencing, particularly as a replacement for traditional brick and metal boundary treatments, also led to the erosion of the area's special character.

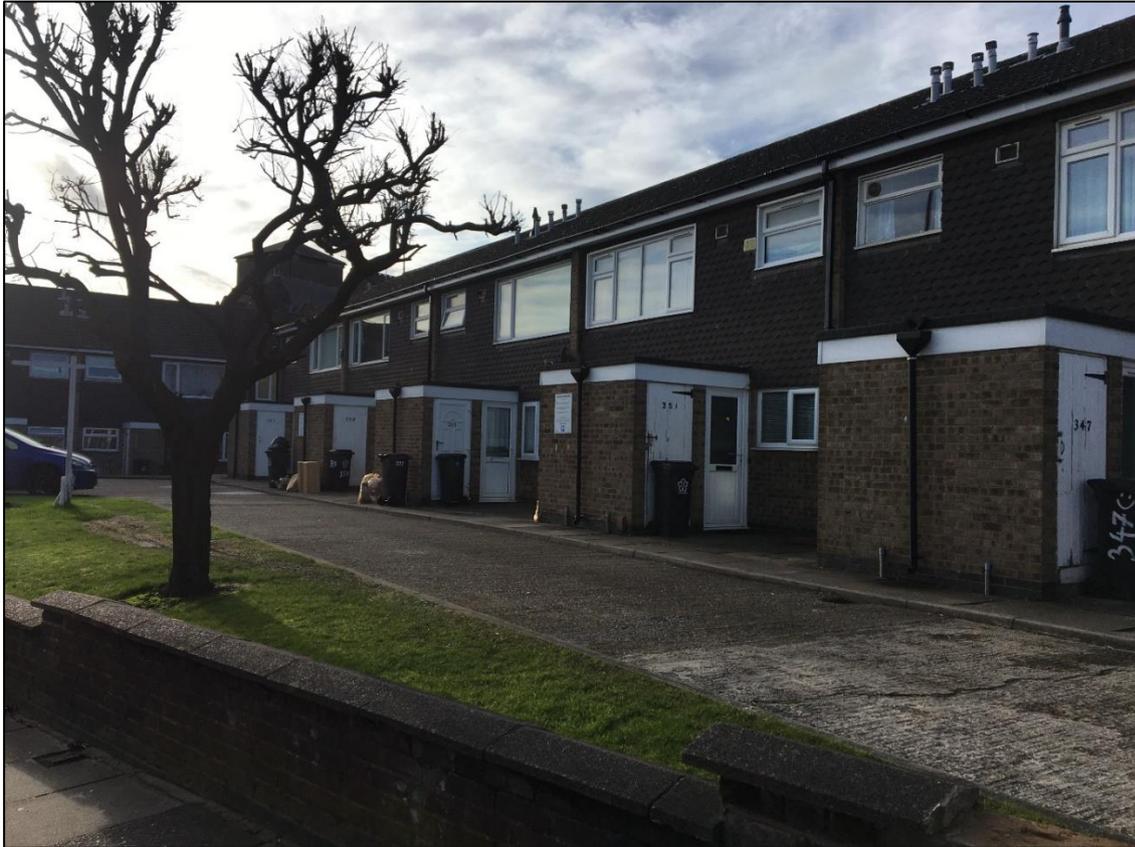
Figure 38: The Convent Court is a modernist development built with little reference to the area's historic building stock.

14.12. There are few developments the area that detract from its character. These include the Convent Court, located on the prominent corner of a busy junction adjacent the Grade II Listed Former St Paul's Church. Recessed from the pavement, with poor boundary definition and a row of utilitarian garages to north, it does detract from the otherwise attractive townscape of the area. The building at 46 Wentworth Road makes some concessions to the neighbouring properties but has a poorly articulated, overtly bland frontage and clashing proportions.

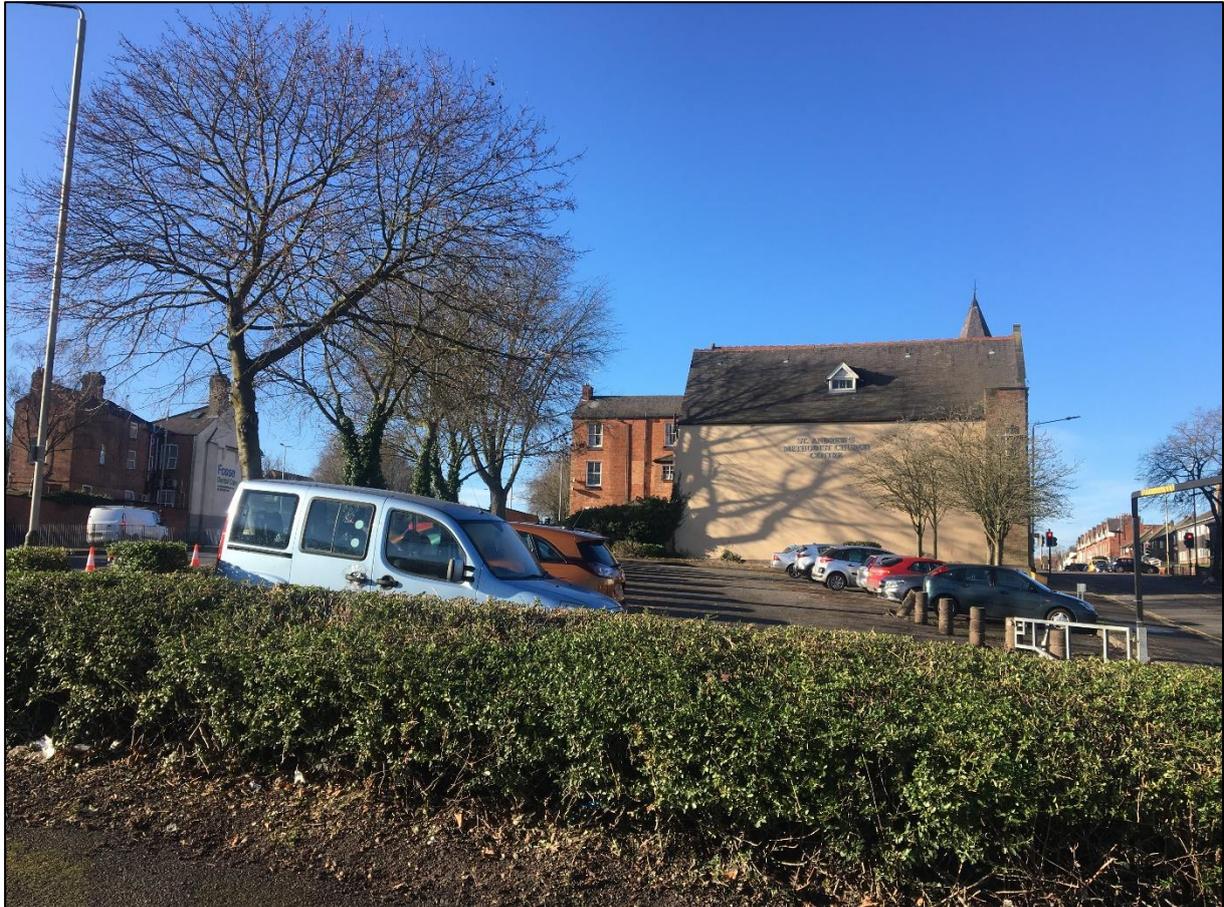
Figure 39: The surface level car park adjacent the St Andrew's Methodist Church, with potential for enhancement or redevelopment.
